LESSONS LEARNED FROM HRSC USED AT LUST SITES

Lessons Learned from 150 HRSC Investigations and Failed UST Remediation Sites

High Resolution Site Characterization in Alabama

A Strategy to Advance UST Release Cleanups in Alabama

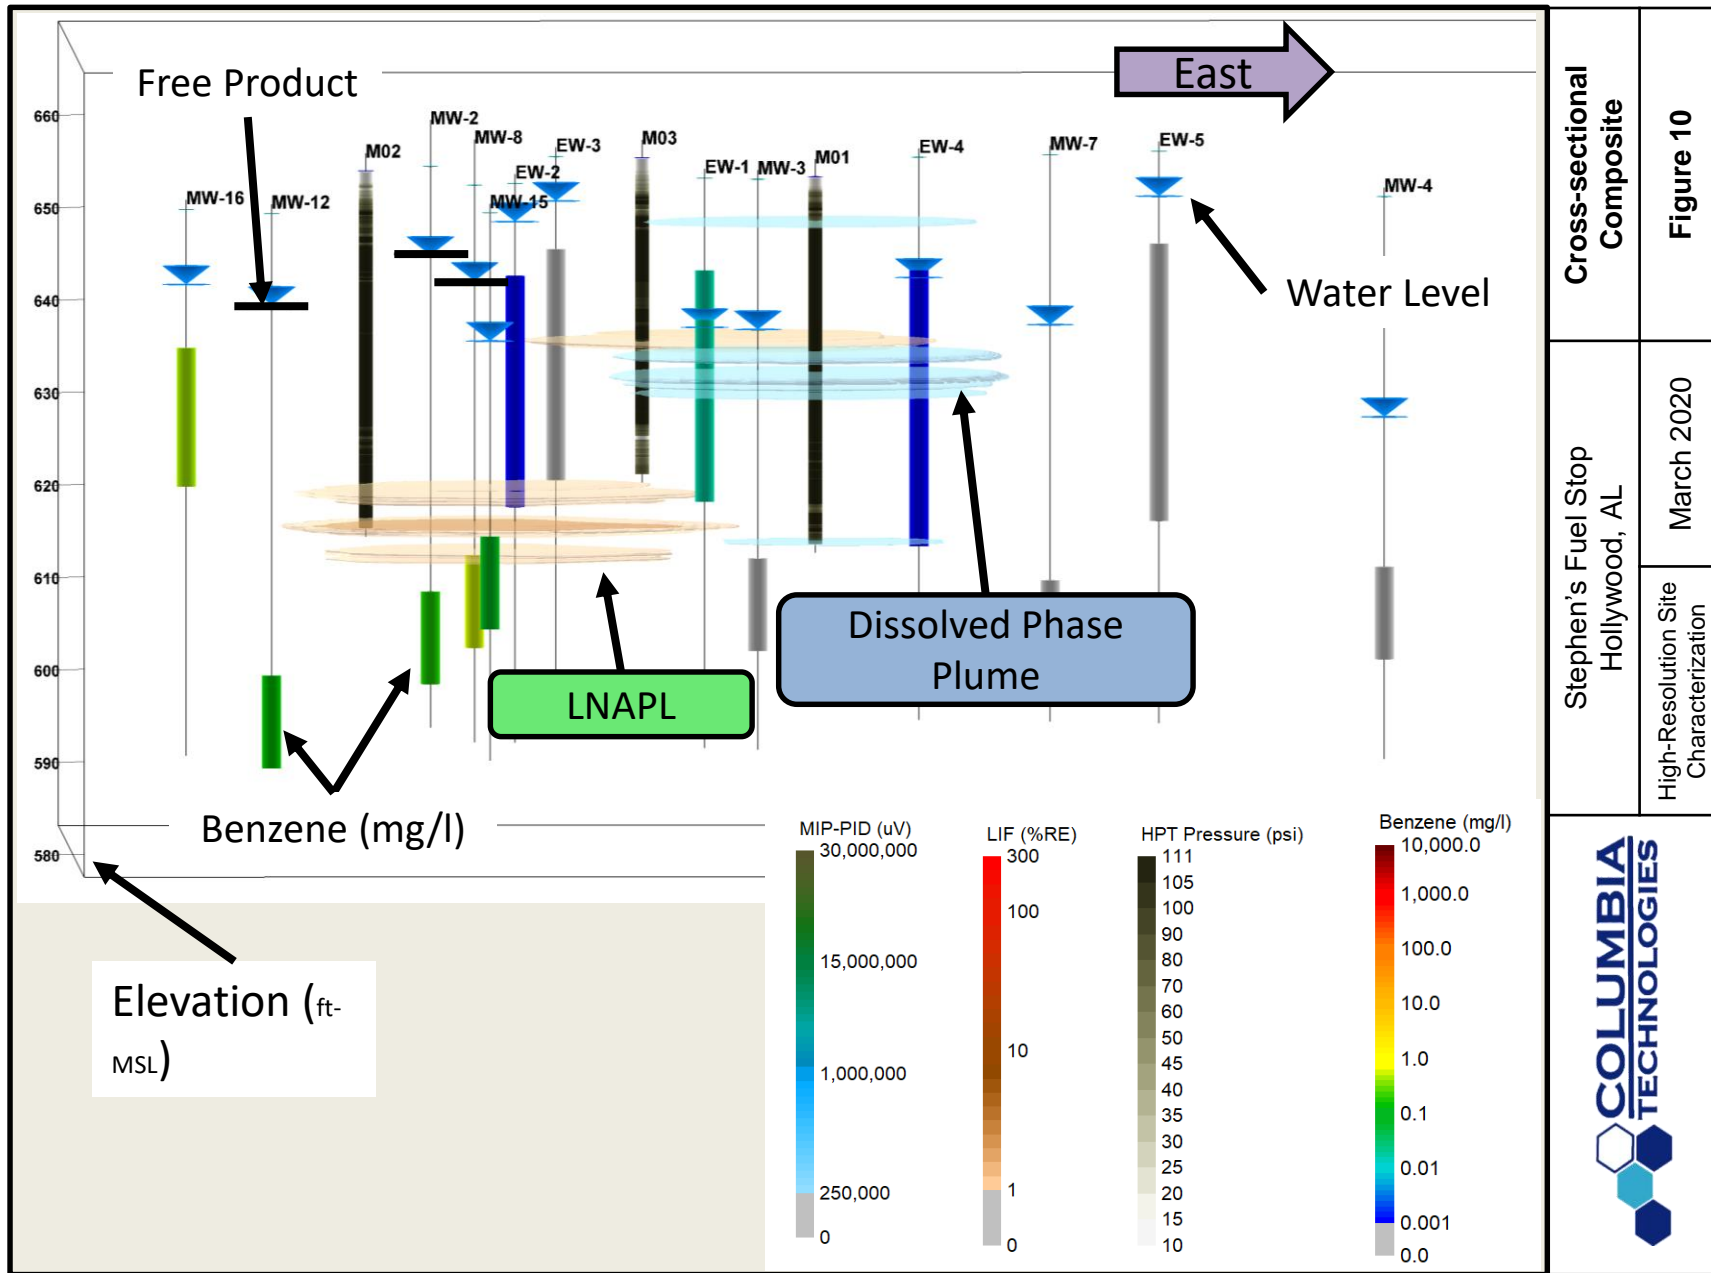
Cross-sectional Composite
Figure 10

Stephen's Fuel Stop
Hollywood, AL

High-Resolution Site
Characterization
March 2020

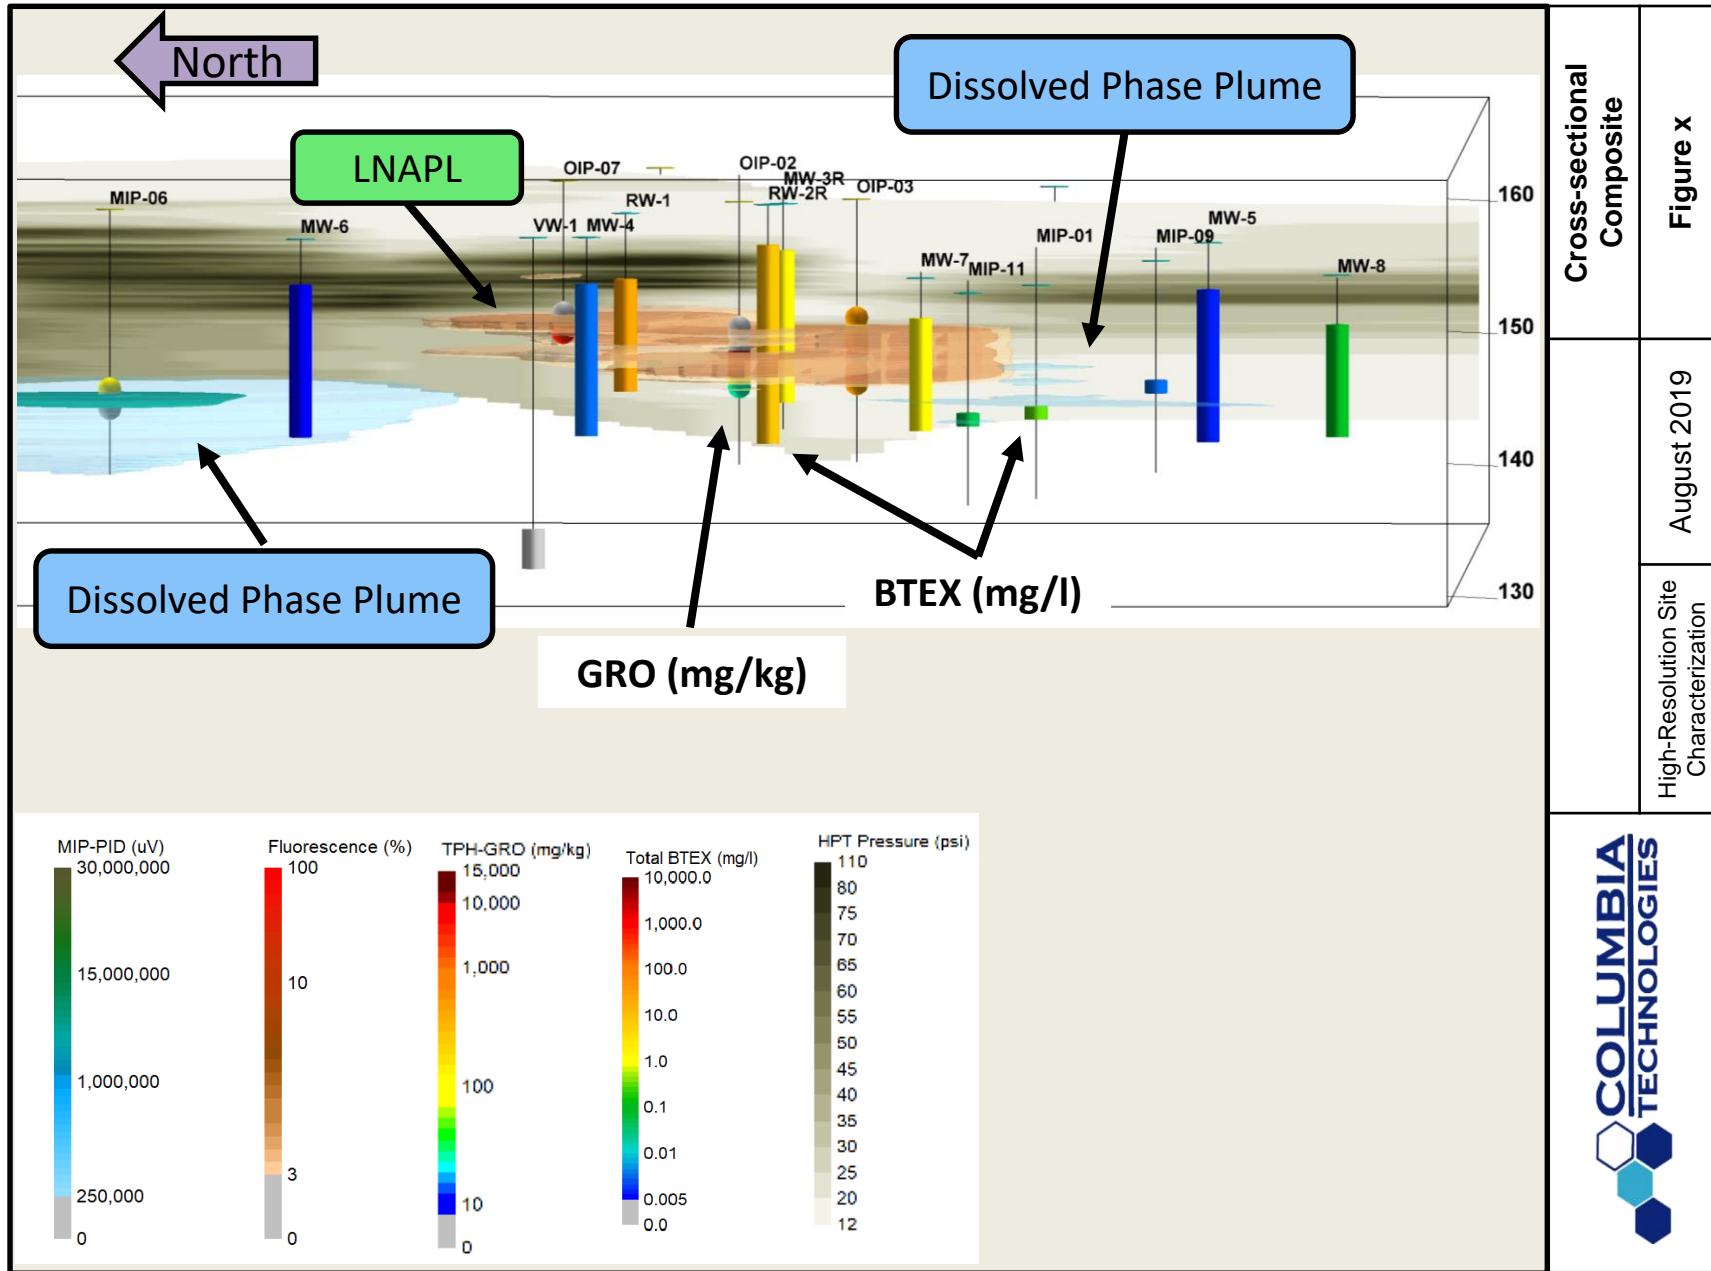
Cross-sectional Composite
Figure x

August 2019

High-Resolution Site Characterization

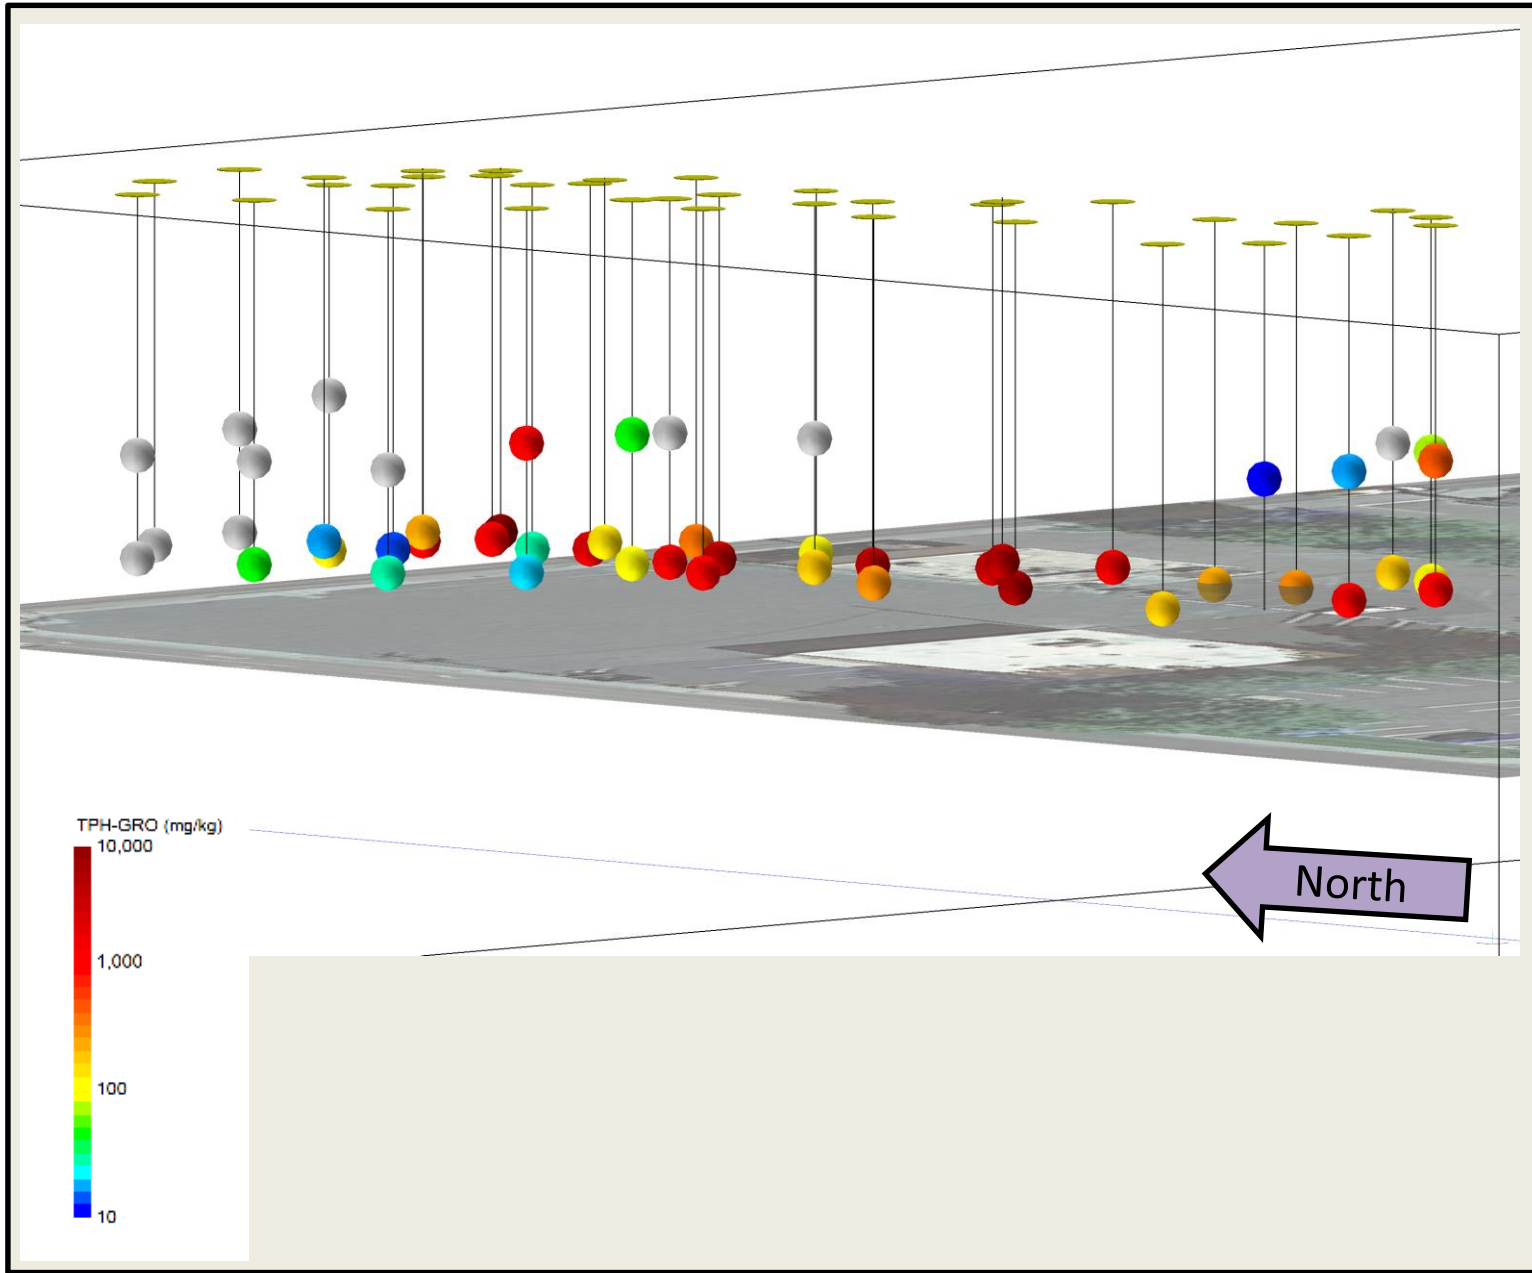
High-Resolution Site Characterization	March 2019	GRO Soil Samples from 2015
			Figure 13

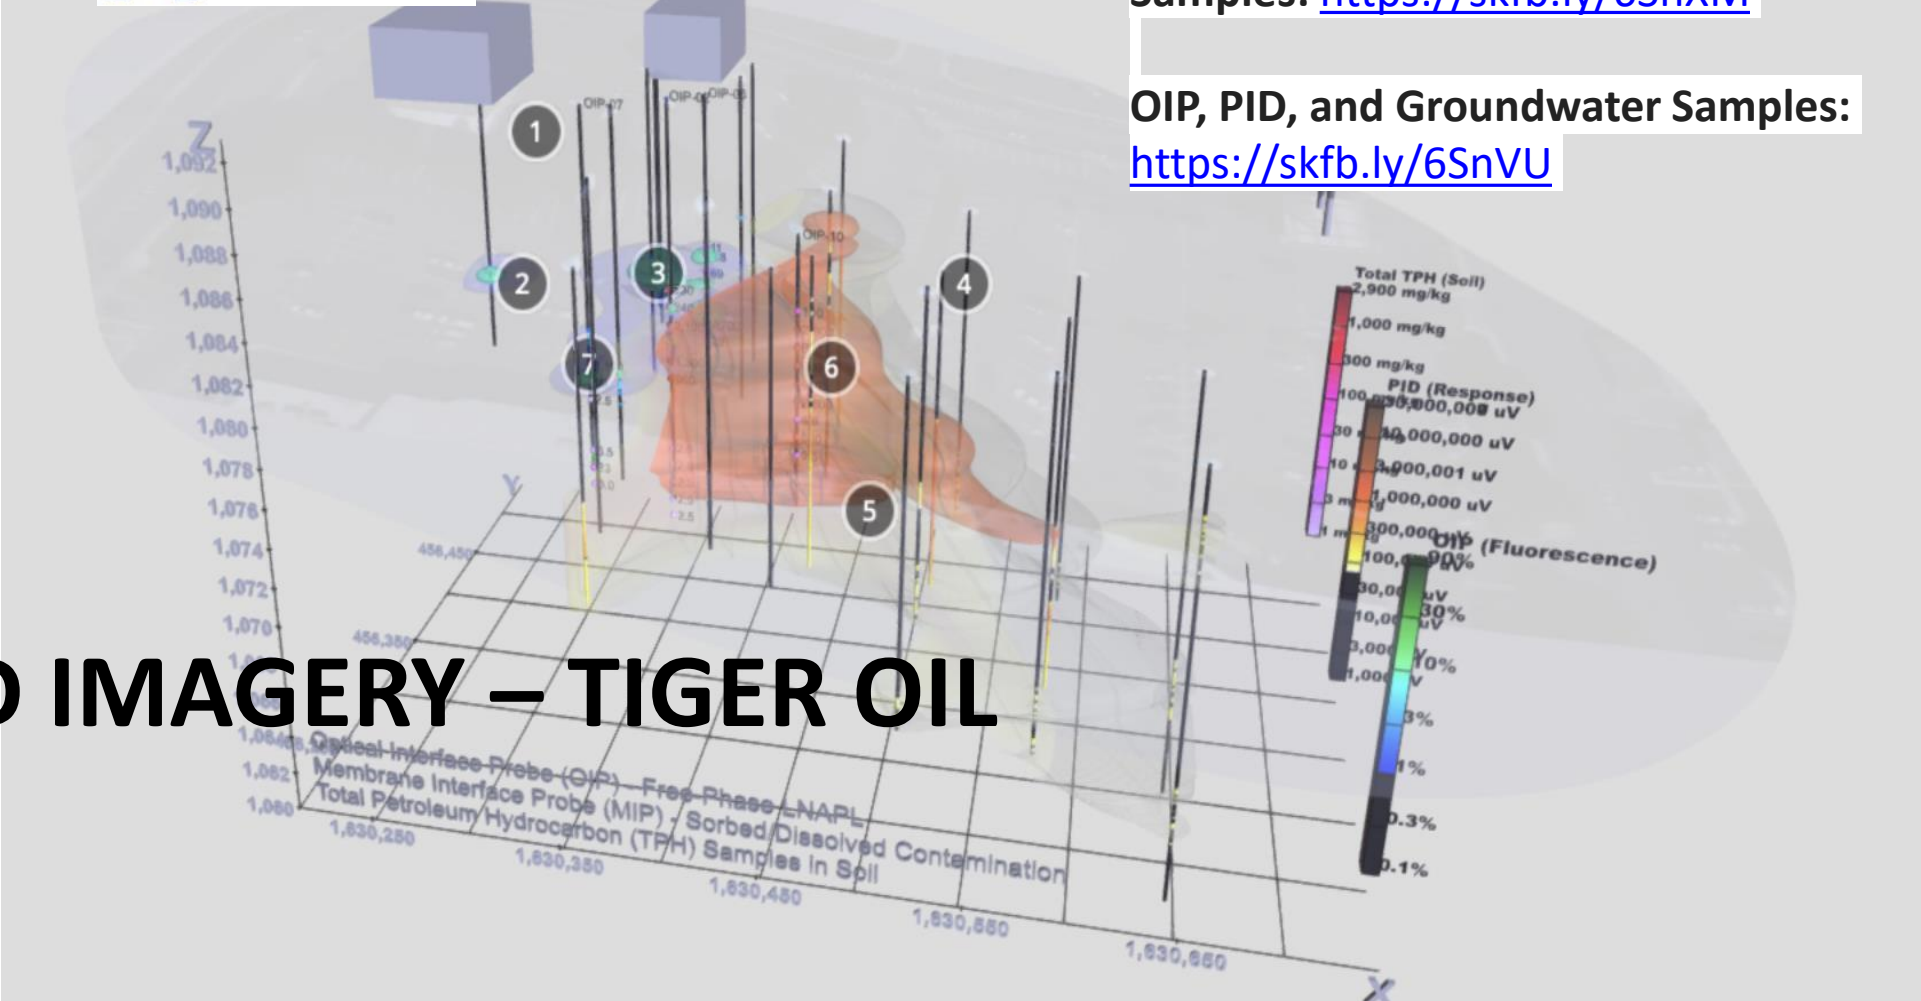
OIP, PID, and Co-Located Soil Samples: <https://skfb.ly/6SnXM>

OIP, PID, and Groundwater Samples: <https://skfb.ly/6SnVU>

3D IMAGERY – TIGER OIL

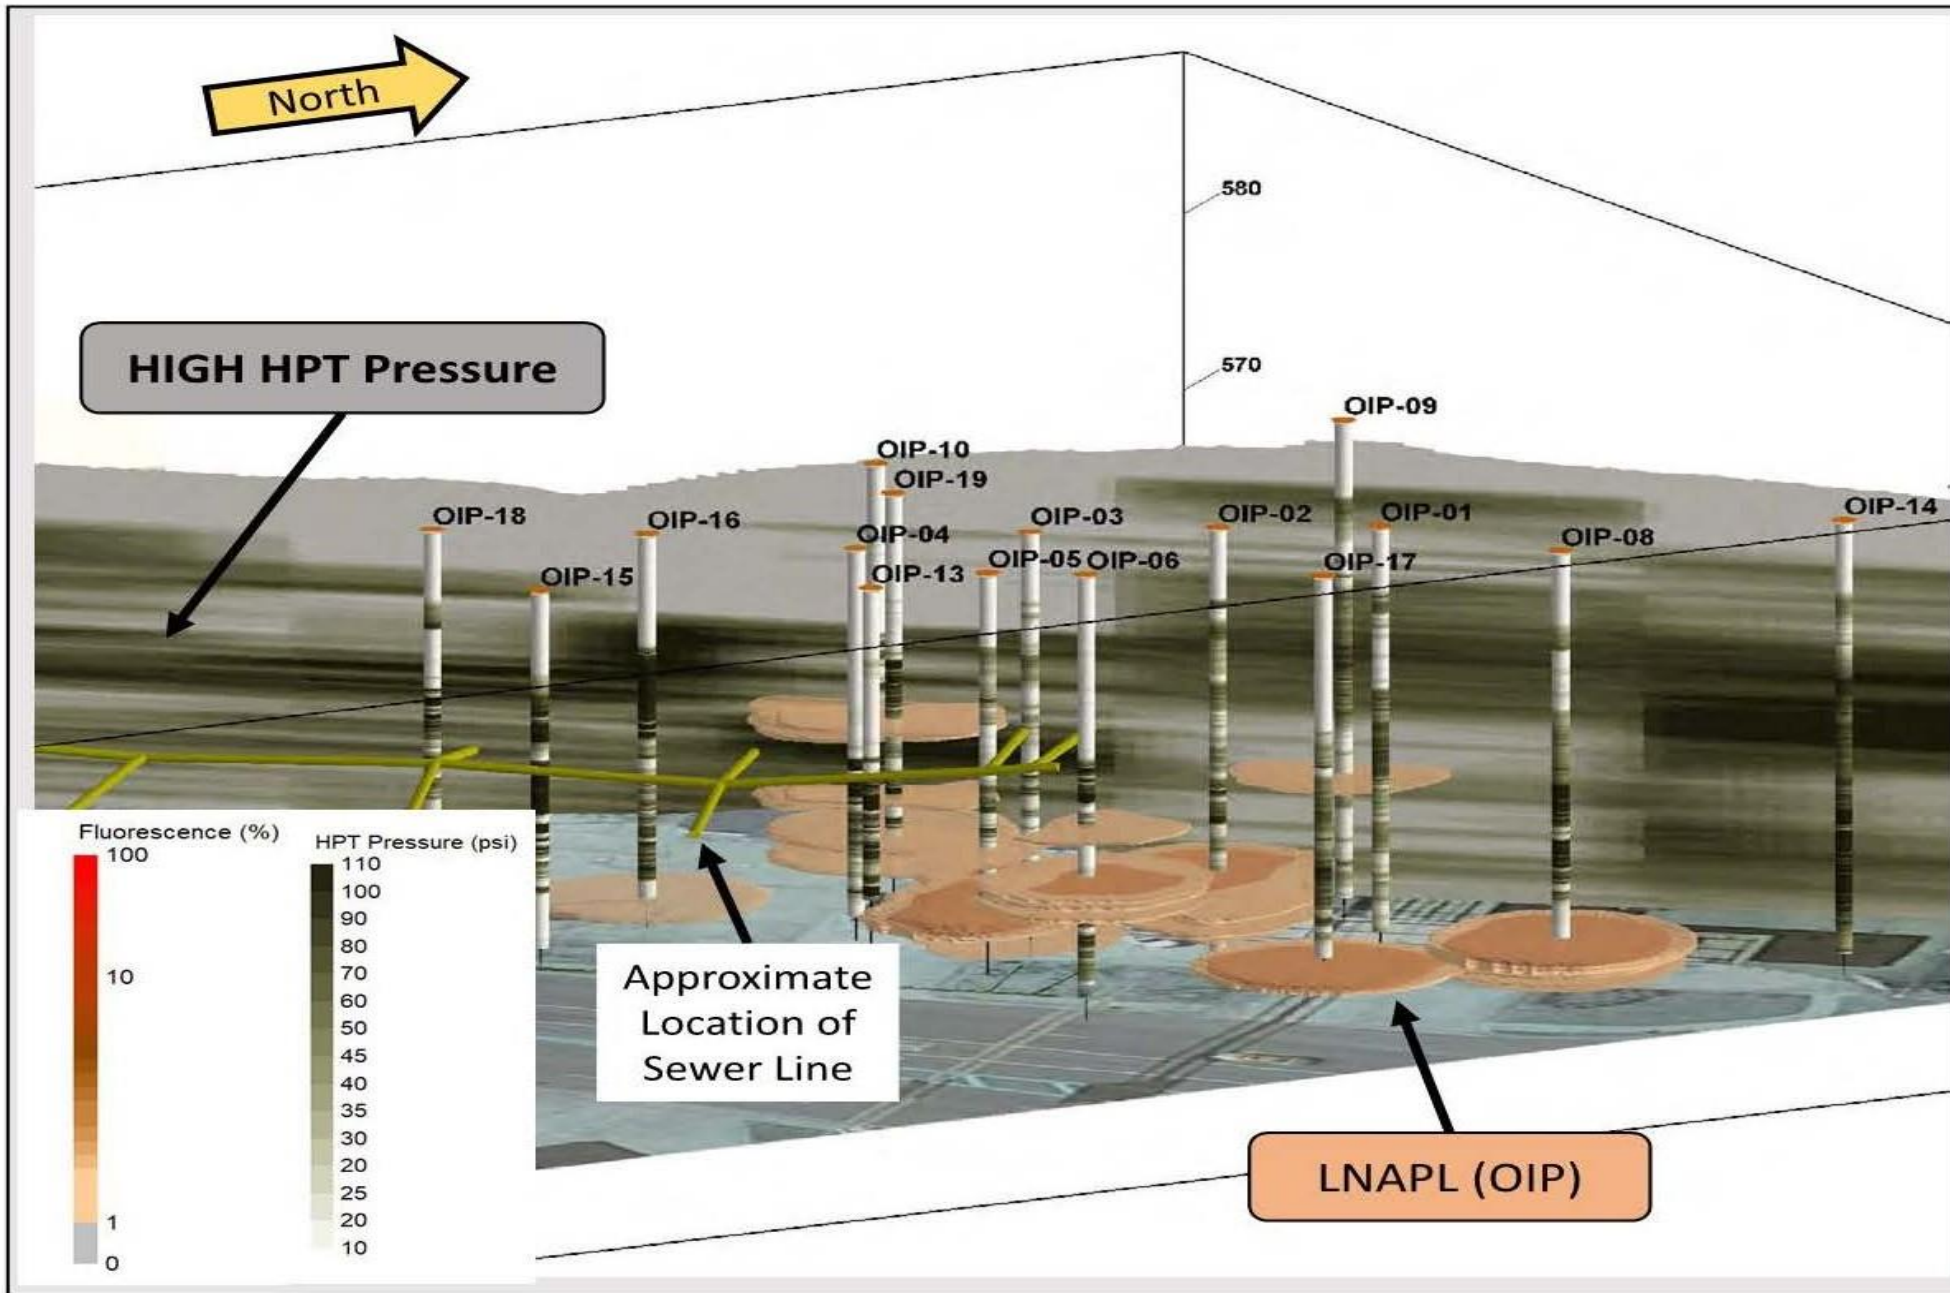
Riverside Shell ER Decatur, Alabama		HRSC Direct Sensing Results
High-Resolution Site Characterization	February 2020	Figure 10

- ▶ Emergency response in January 2020
- ▶ High resolution investigation performed in early February 2020
- ▶ The purpose of the study was to accurately delineate both vertically and laterally any residual light non-aqueous phase liquid (LNAPL) at the site, to identify the soil structure in which any LNAPL resides for permeability and potential for recovery, and to identify pathways from the source area to the sanitary sewer.
- ▶ Remediation system installed in late January 2020

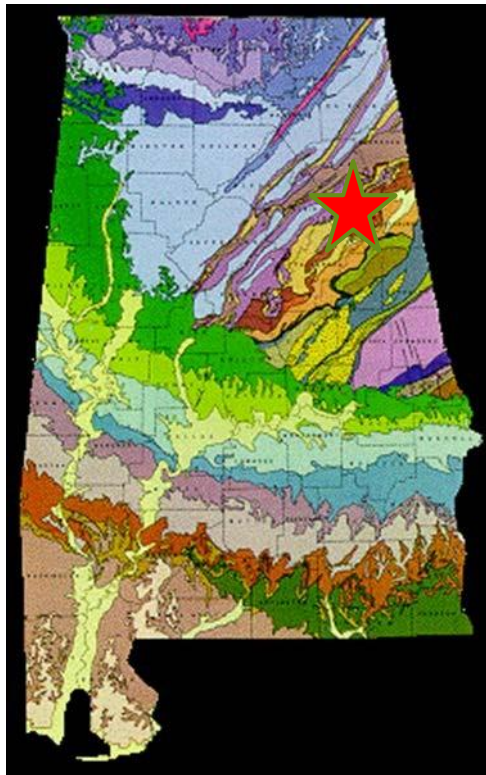
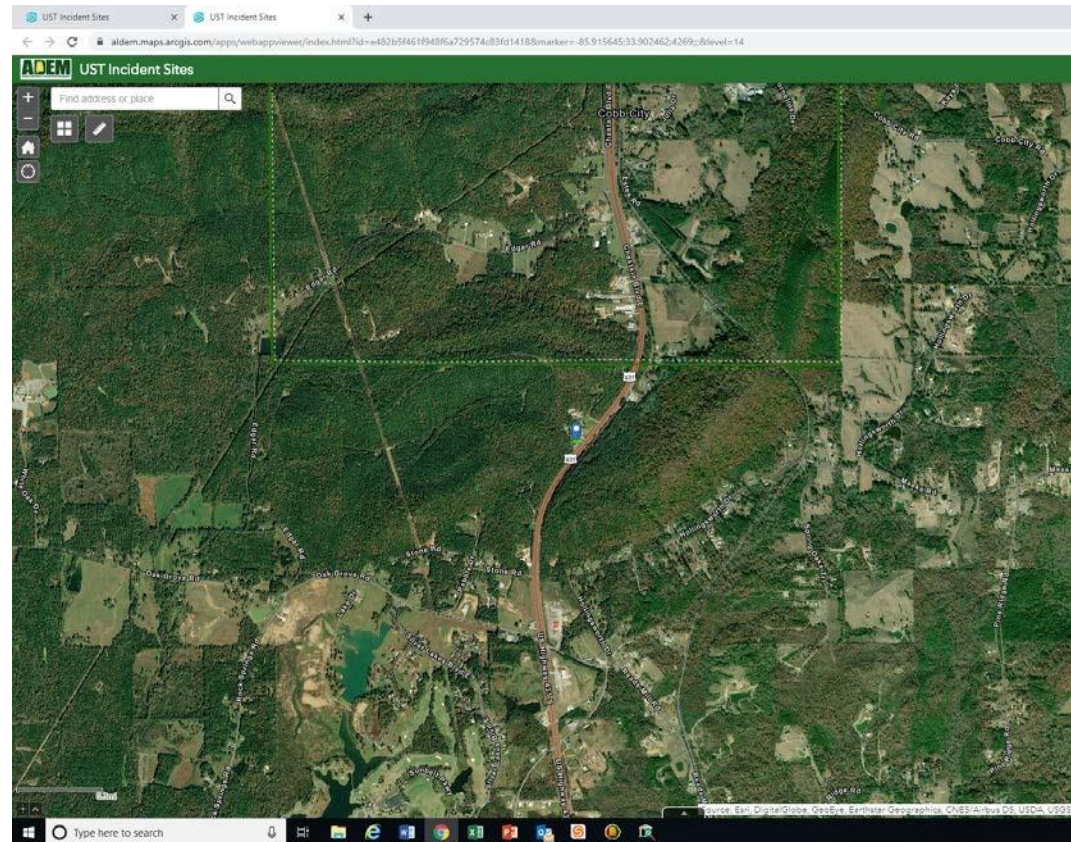
Vertical Extent of Contamination

► Glencoe, Alabama

Well ID	Benzene Conc. (mg/L)
MW-1	5.34
MW-2	NS
MW-3	1.36
MW-4	0.867
MW-5	0.298
MW-6	ND
MW-7	0.237
MW-8	NS
MW-12	NS
MW-20	NS
MW-21	NS

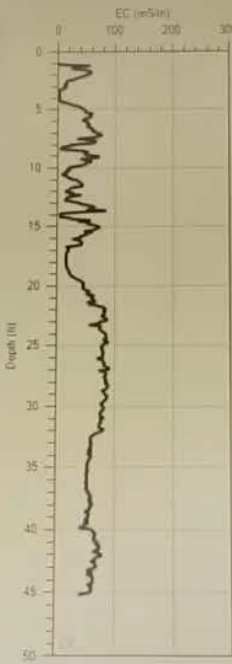
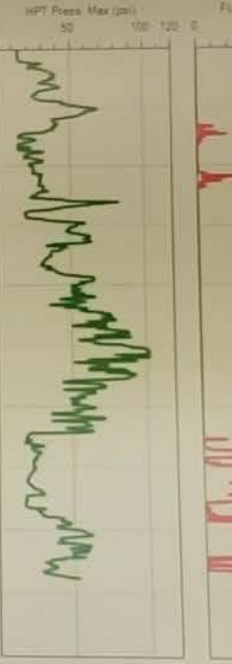
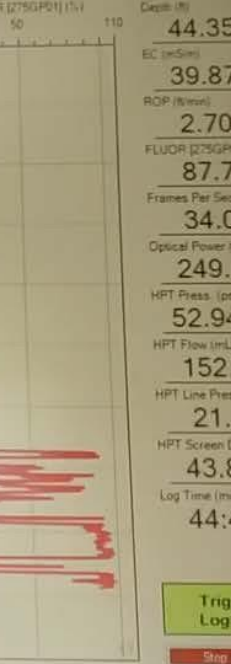
Depth (ft) **44.35**
 EC (mS/cm) **39.87**
 ROP (Kw/cm) **2.70**
 FLUOR (275GPD1) (%) **87.7**
 Frames Per Second **34.0**
 Optical Power (mW) **249.2**
 HPT Press. (psi) **52.949**
 HPT Flow (mL/min) **152.7**
 HPT Line Press. (psi) **21.9**
 HPT Screen Depth (ft) **43.86**
 Log Time (min:sec) **44:42**

Visual Confirmation of LNAPL
(Zone 1 wetting fluid)

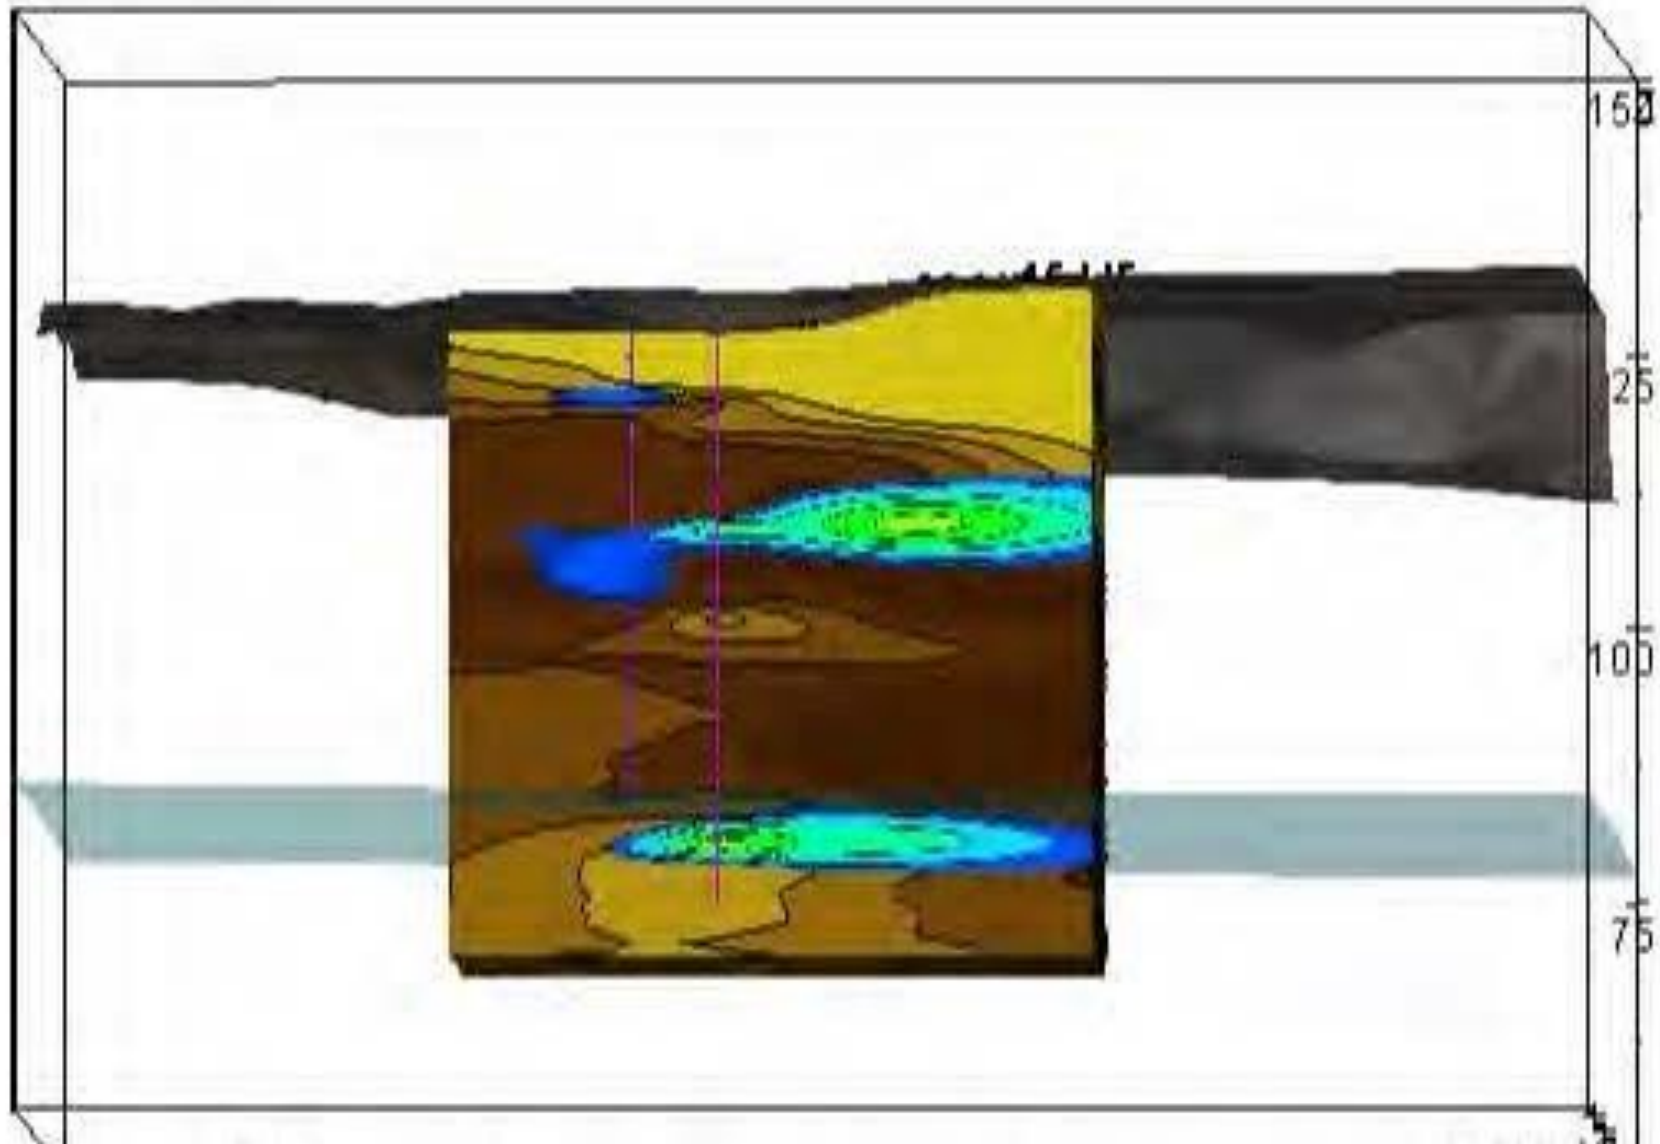
3D Visualization of UVOST Signal
PPM Consultants - Wilson Service Center
Spanish Fort, AL
Vertical Exaggeration = 5:1

UVOST Response Above 1.5% RE

Northing Cut:
243,340

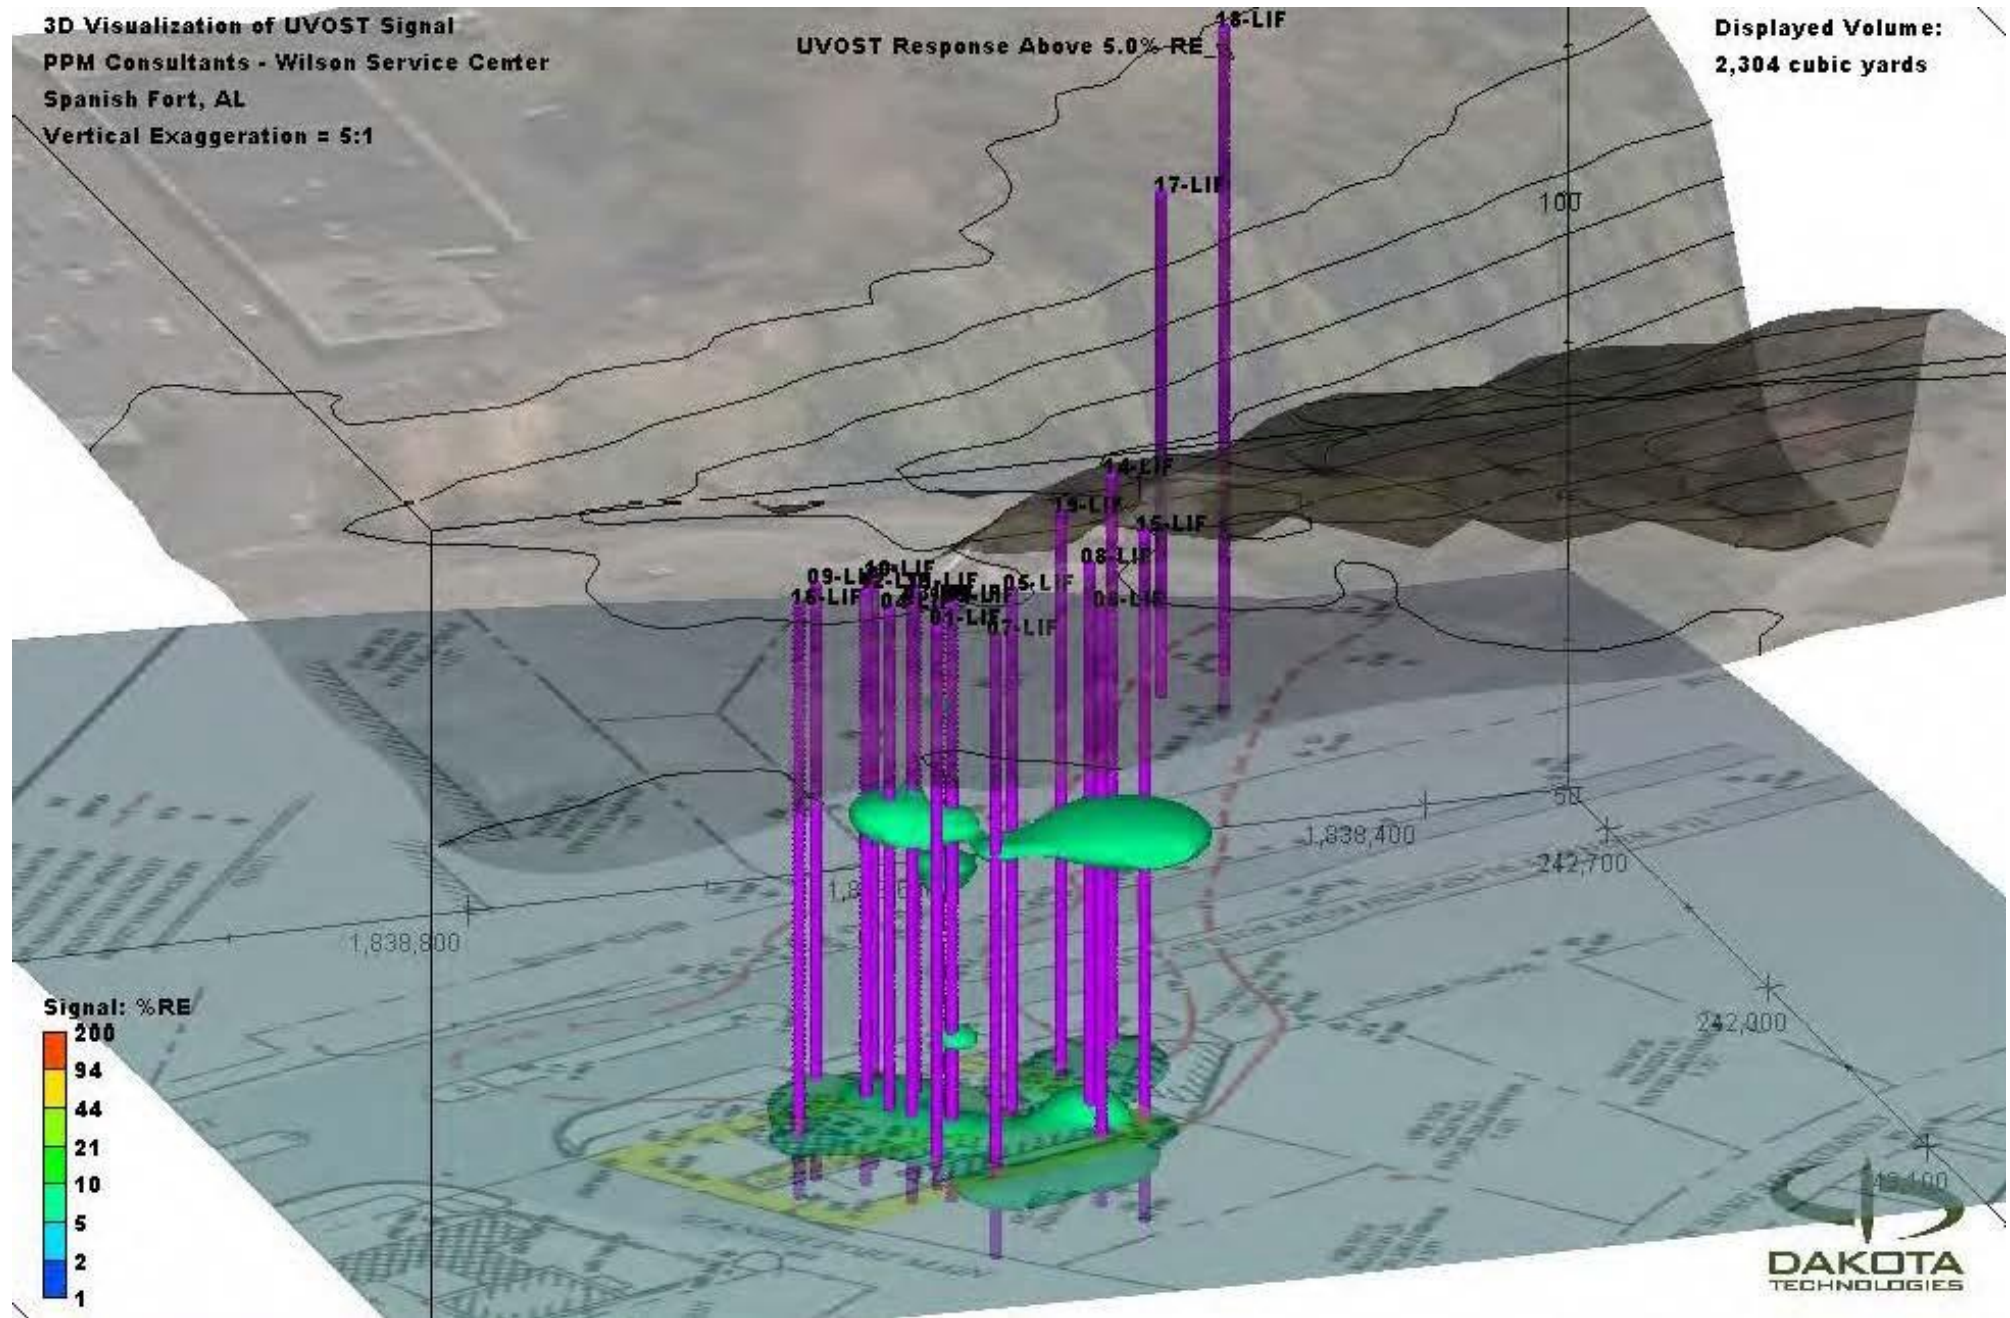
3D Visualization of UVOST Signal
PPM Consultants - Wilson Service Center
Spanish Fort, AL
Vertical Exaggeration = 5:1

UVOST Response Above 5.0% RE

Displayed Volume:
2,304 cubic yards

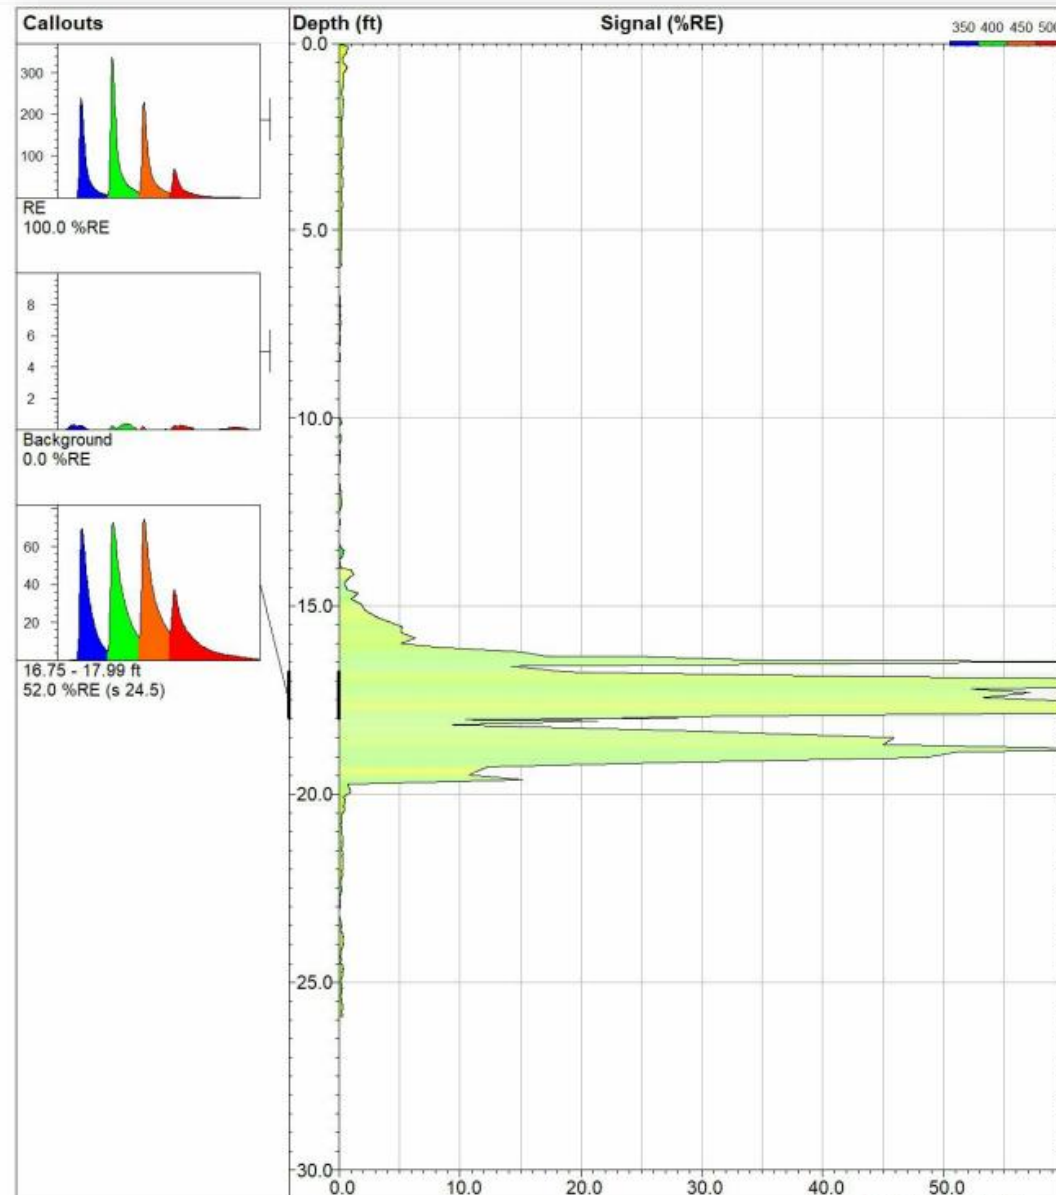
L06		
Site: Larry Body Shop 14183	Y Coord.(Lat-N) / System: Unavailable / NA	Final depth: 25.91 ft
	X Coord.(Lng-E) / Fix: Unavailable / NA	Max signal: 102.3 %RE @ 17.02 ft
Operator / Unit:	Elevation:	Date & Time:

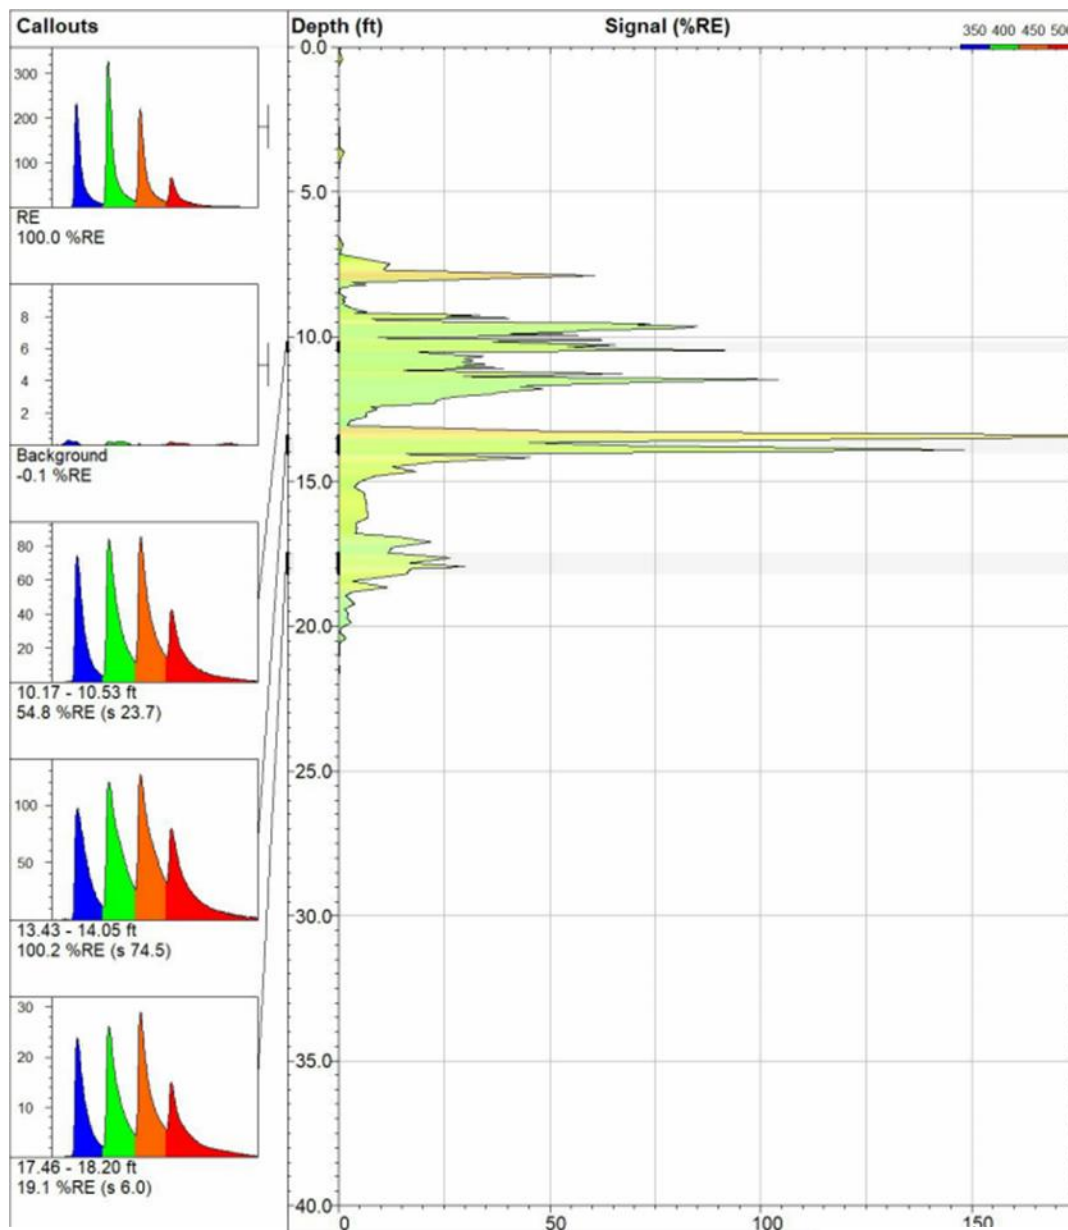
L07

Site: Larry Body Shop 14183	Y Coord. (Lat-N) / System: Unavailable / NA	Final depth: 25.95 ft
Client / Inh:	X Coord. (Lng-E) / Fix: Unavailable / NA	Max signal: 205.8 %RE @ 13.43 ft
Op MMA / UVOST1005	Activation: Unavailable	Date & Time: 2019-08-07 08:01 EDT

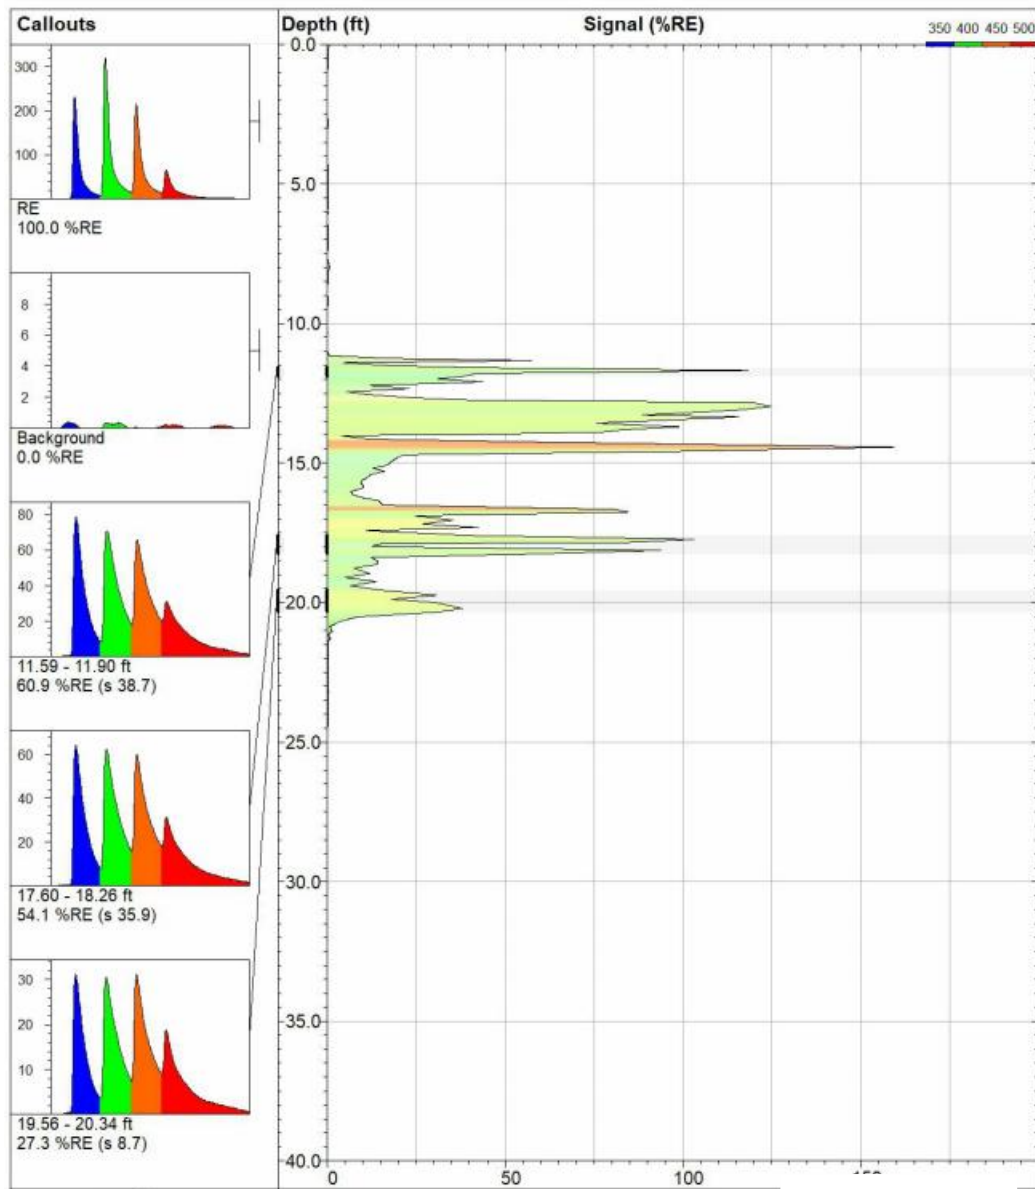
L08

Site: Larrv Bodv Shop 14183	Y Coord.(Lat-N) / System: Unavailable / NA	Final depth: 25.90 ft
Operator / Unit: MMA / UVOST1005	X Coord.(Lng-E) / Fix: Unavailable / NA	Max signal: 160.0 %RE @ 14.43 ft
	Elevation: Unavailable	Date & Time: 2019-08-07 08:26 EDT

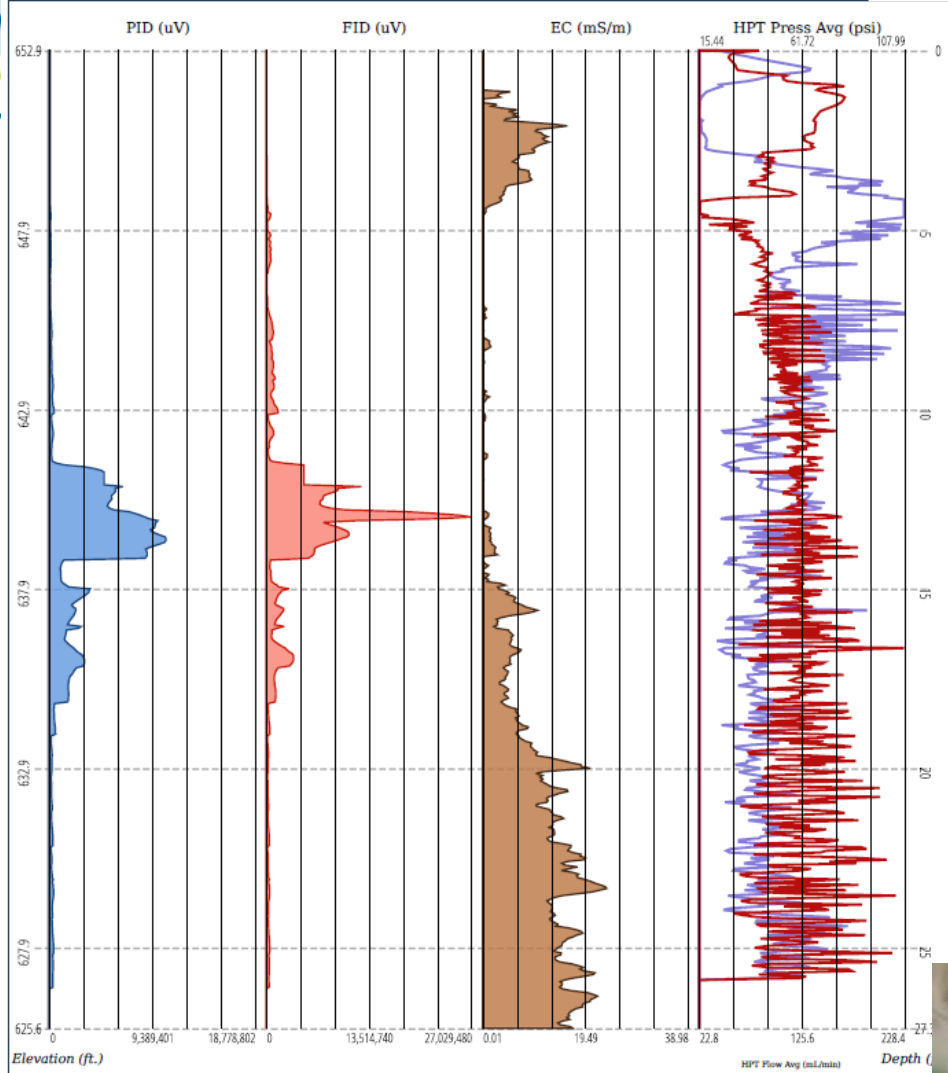
M03 MHP COLLECTIVE

14183 - Larry's Body Shop

X Scale: collective
 Y Scale: individual
 Lat/Lng: 34.5140, -82.0027
 Elevation Range: 652.9 - 625.6 ft.
 Depth Range: 0 - 27.3 ft.
