LESSONS LEARNED FROM HRSC USED AT LUST SITES

Lessons Learned from 150 HRSC Investigations and Failed UST Remediation Sites

High Resolution Site Characterization in Alabama

A Strategy to Advance UST Release Cleanups in Alabama

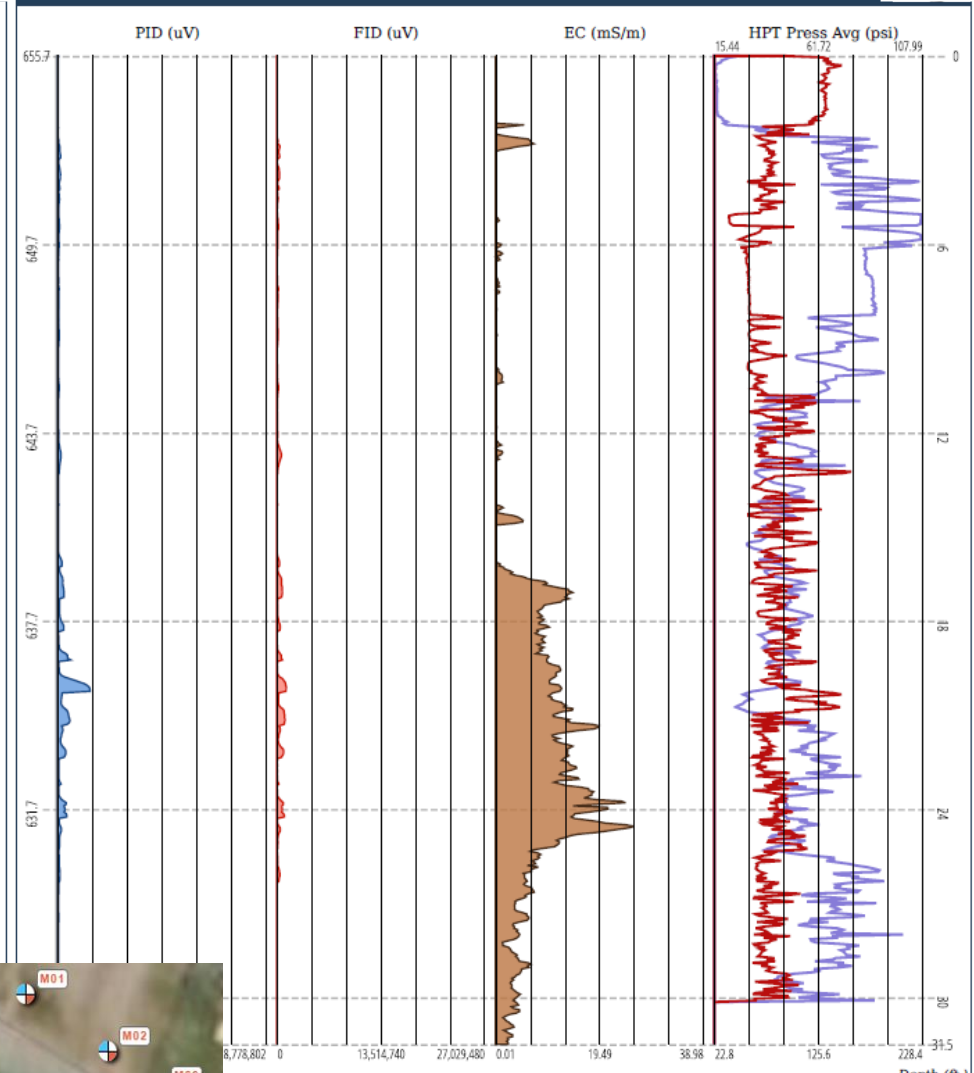
M07 MHP COLLECTIVE

14183 - Larry's Body Shop

X Scale: collective
 Y Scale: individual
 Lat/Lng: 34.5139, -82.0028
 Elevation Range: 655.7 - 624.2 ft.
 Depth Range: 0 - 31.5 ft.

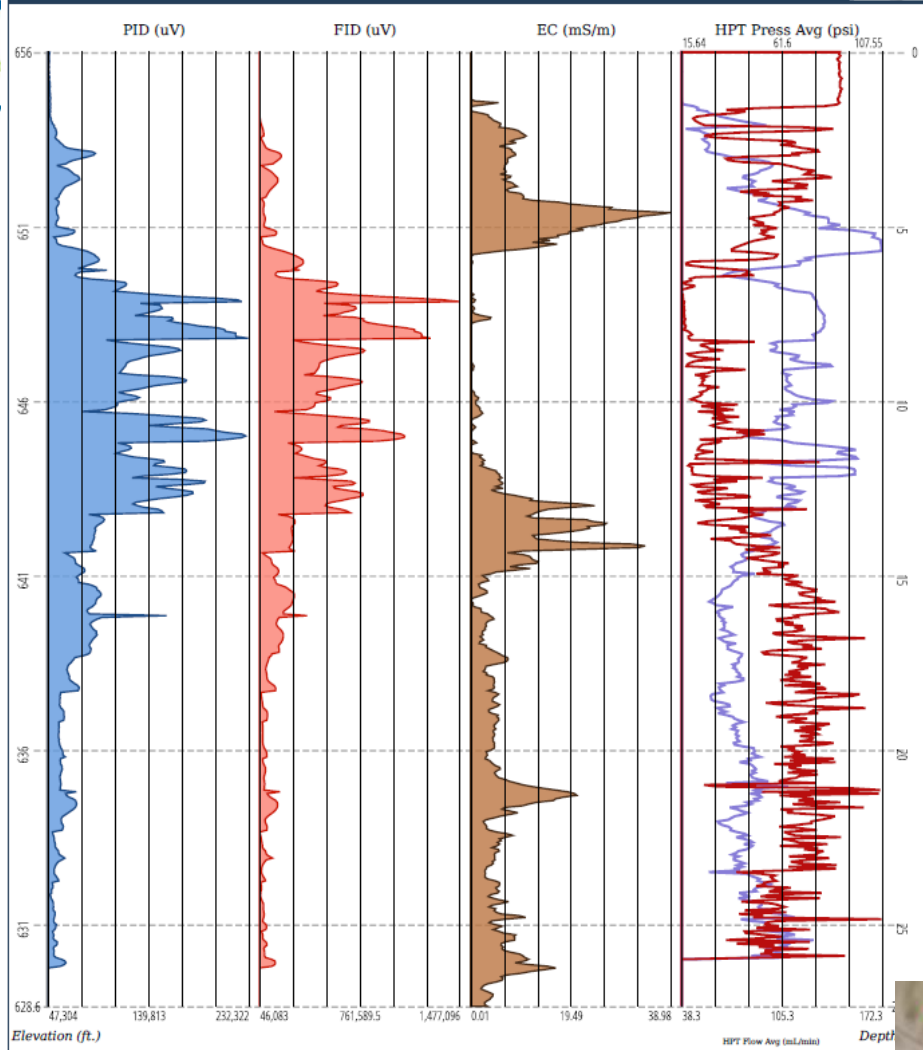
M01 MHP INDIVIDUAL

14183 - Larry's Body Shop

X Scale: individual
 Y Scale: individual
 Lat/Lng: 34.5141, -82.0028
 Elevation Range: 656 - 628.6 ft.
 Depth Range: 0 - 52 ft.

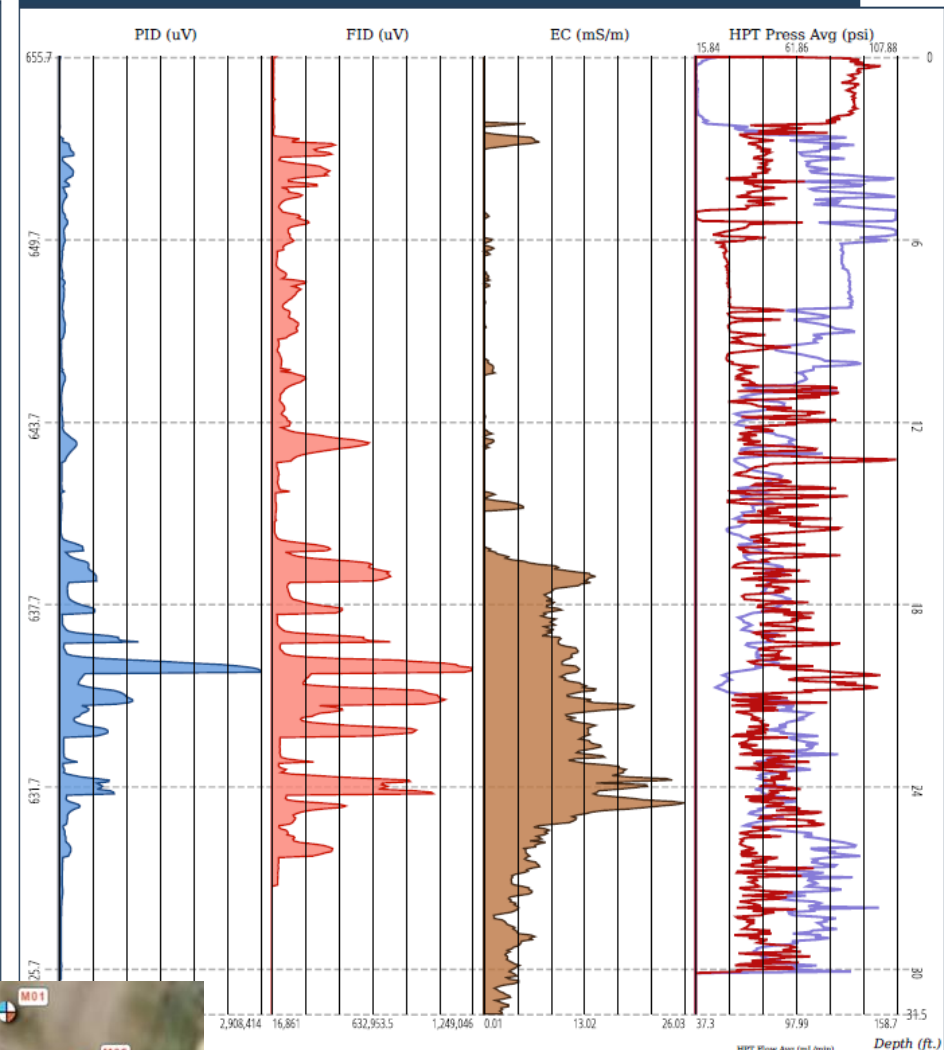
M07 MHP INDIVIDUAL

14183 - Larry's Body Shop

X Scale: individual
 Y Scale: individual
 Lat/Lng: 34.5139, -82.0028
 Elevation Range: 655.7 - 624.2 ft.
 Depth Range: 0 - 31.5 ft.

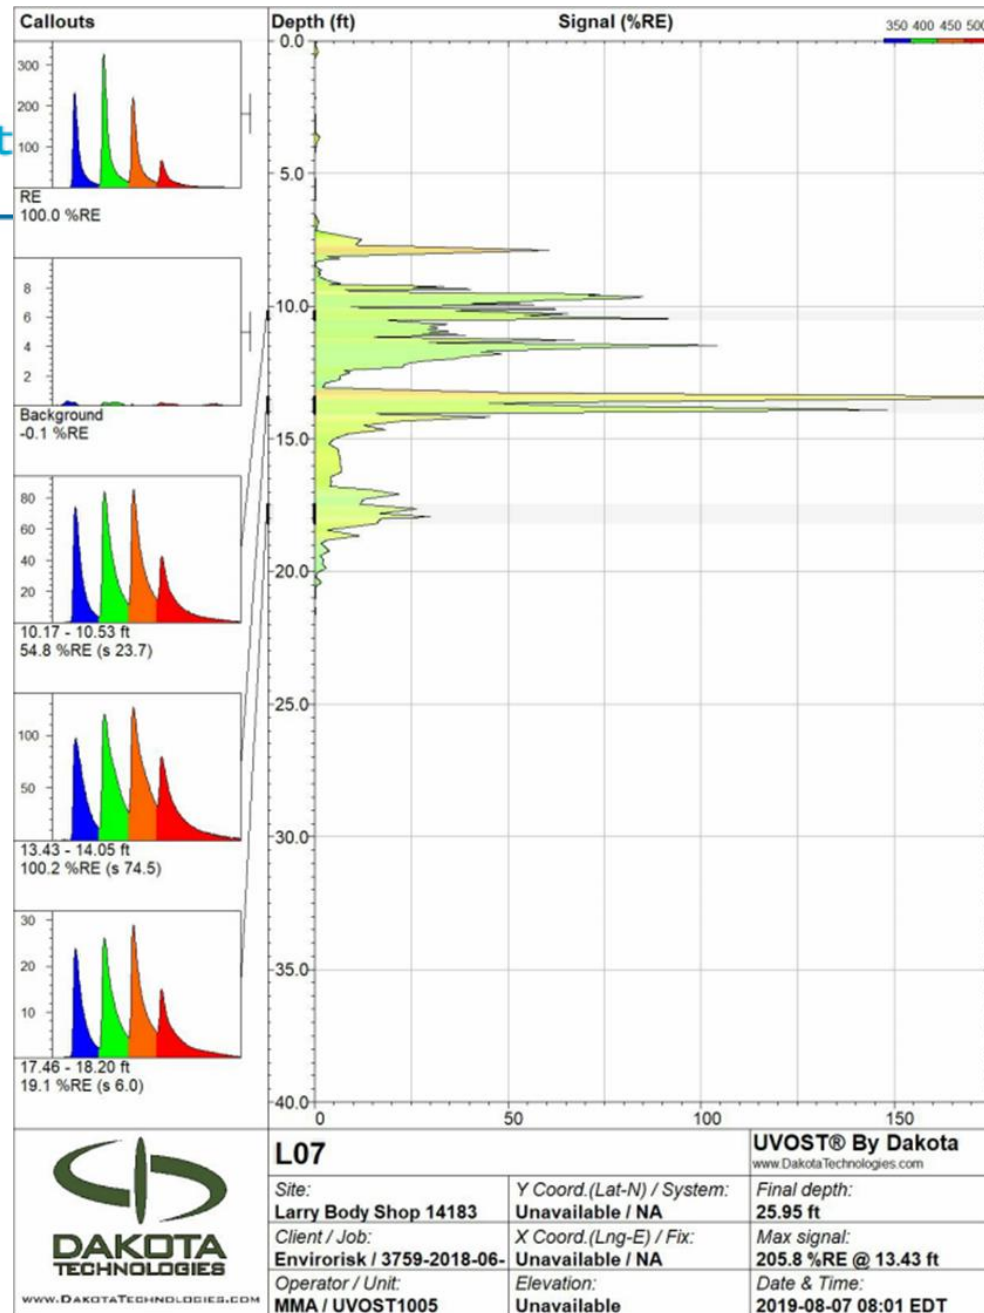
Larry's Body Shop - Results

- Identified Residual LNAPL
- Better source area characterization
- Better idea of groundwater flow and dissolved plume
- Better understanding of site geology
