ELECTRICAL HYDROGEOLOGY OF LNAPL IMPACTS IN FRACTURED ROCK AQUIFERS

Todd Halihan, Ph.D., P.Gp. (CA)

Professor, OSU School of Geology

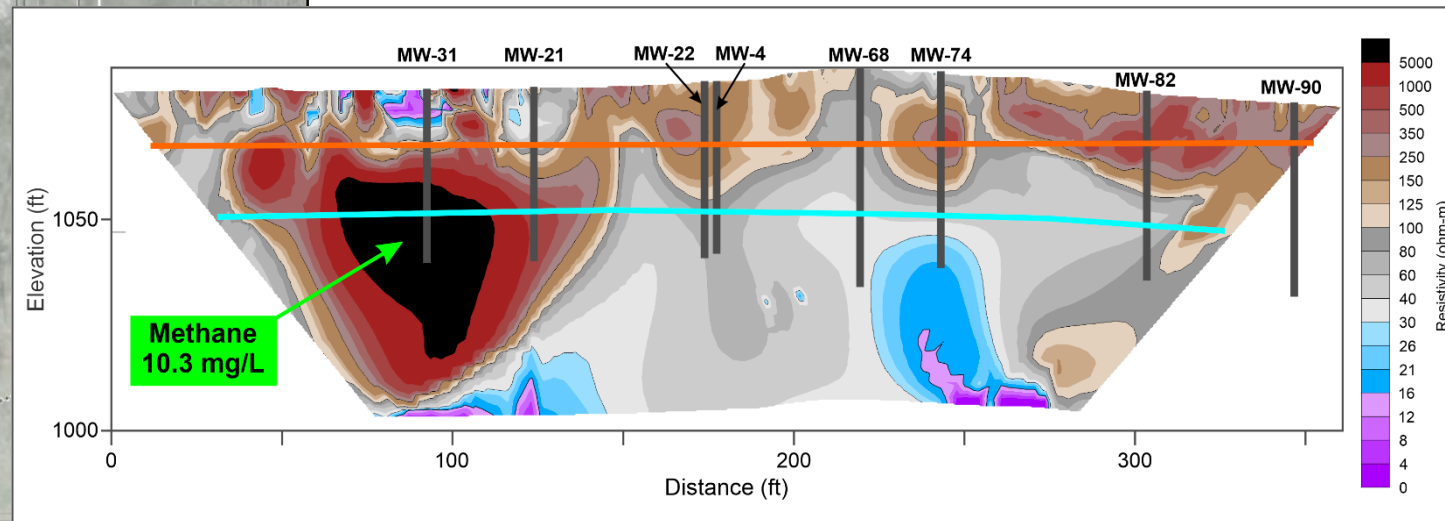
A. BIOACTIVITY CSM ELECTRICALLY RESISTIVE ANOMALIES

Methane production and undegraded LNAPL causing resistive signatures

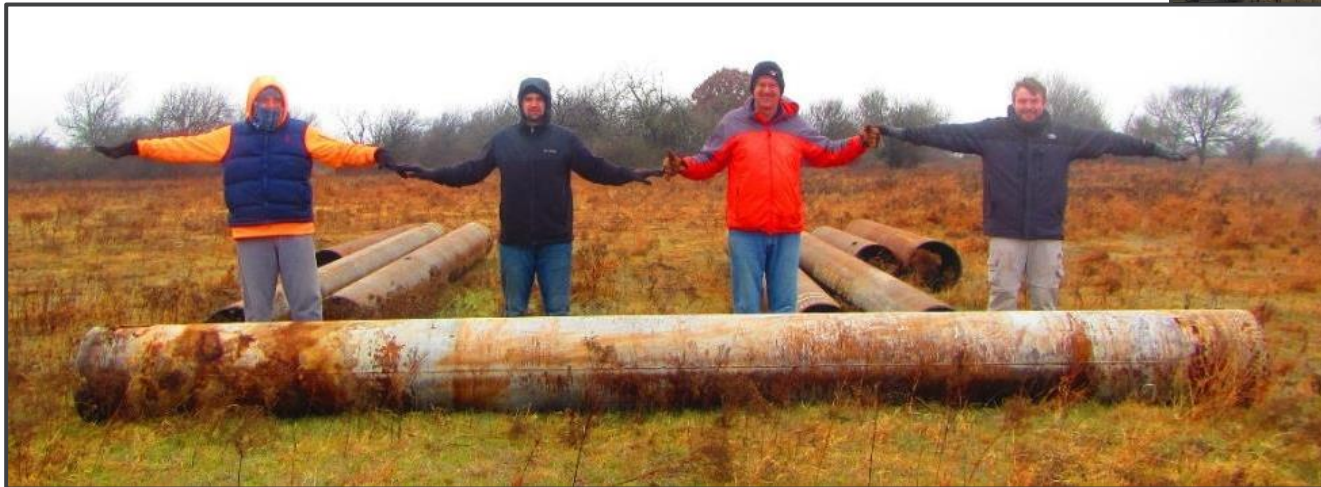
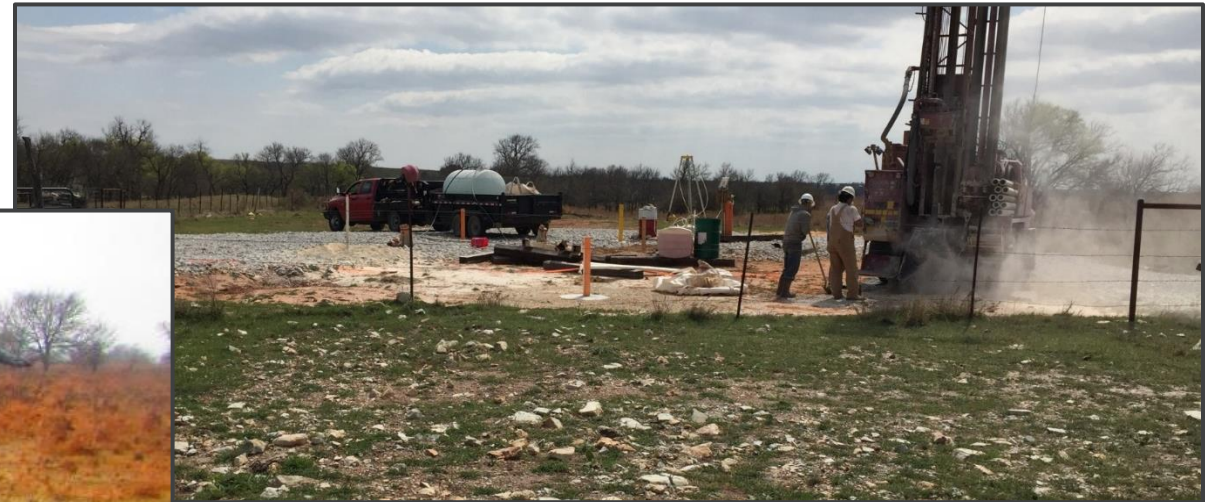
B. DIESEL IN FRACTURED KARSTIC CARBONATES

- AST Released 2000 gal diesel in 2015
- 1 LNAPL impacted water supply well
- Scans in 2015 to determine distribution of LNAPL
- Remediated in under 2 years, all wells non-detect

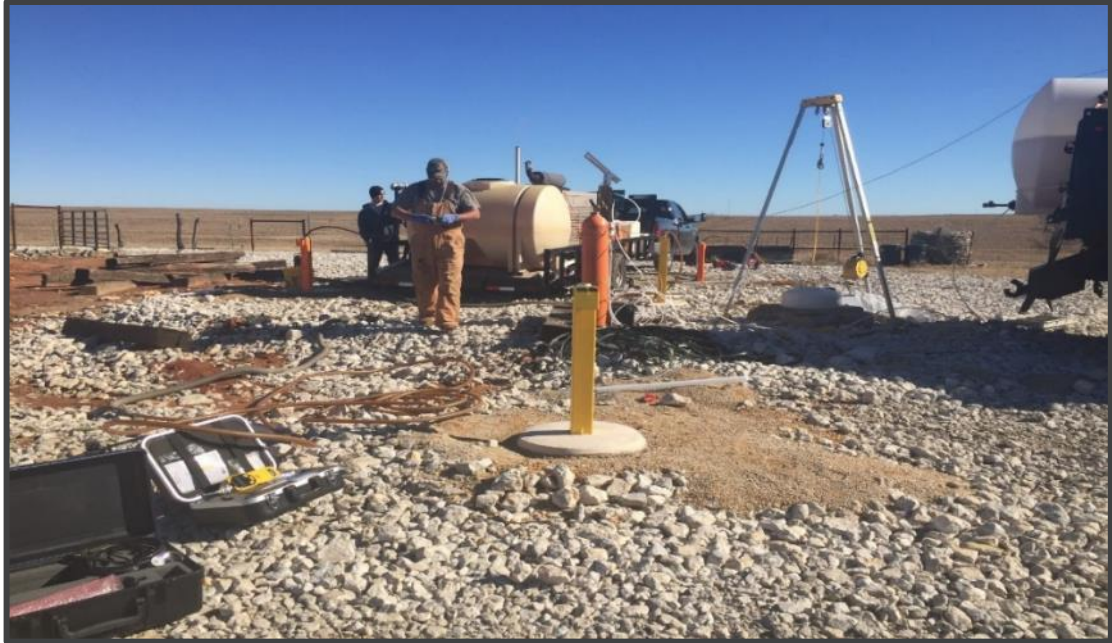
B. MUNICIPAL SUPPLY WELL IMPACT

3D CSM

Targeted Remediation
