# LDT LEAK DETECTION TECHNOLOGY

*UST Inspector Training Webinar 06-23-10*

# Chemical Base Tracer Testing

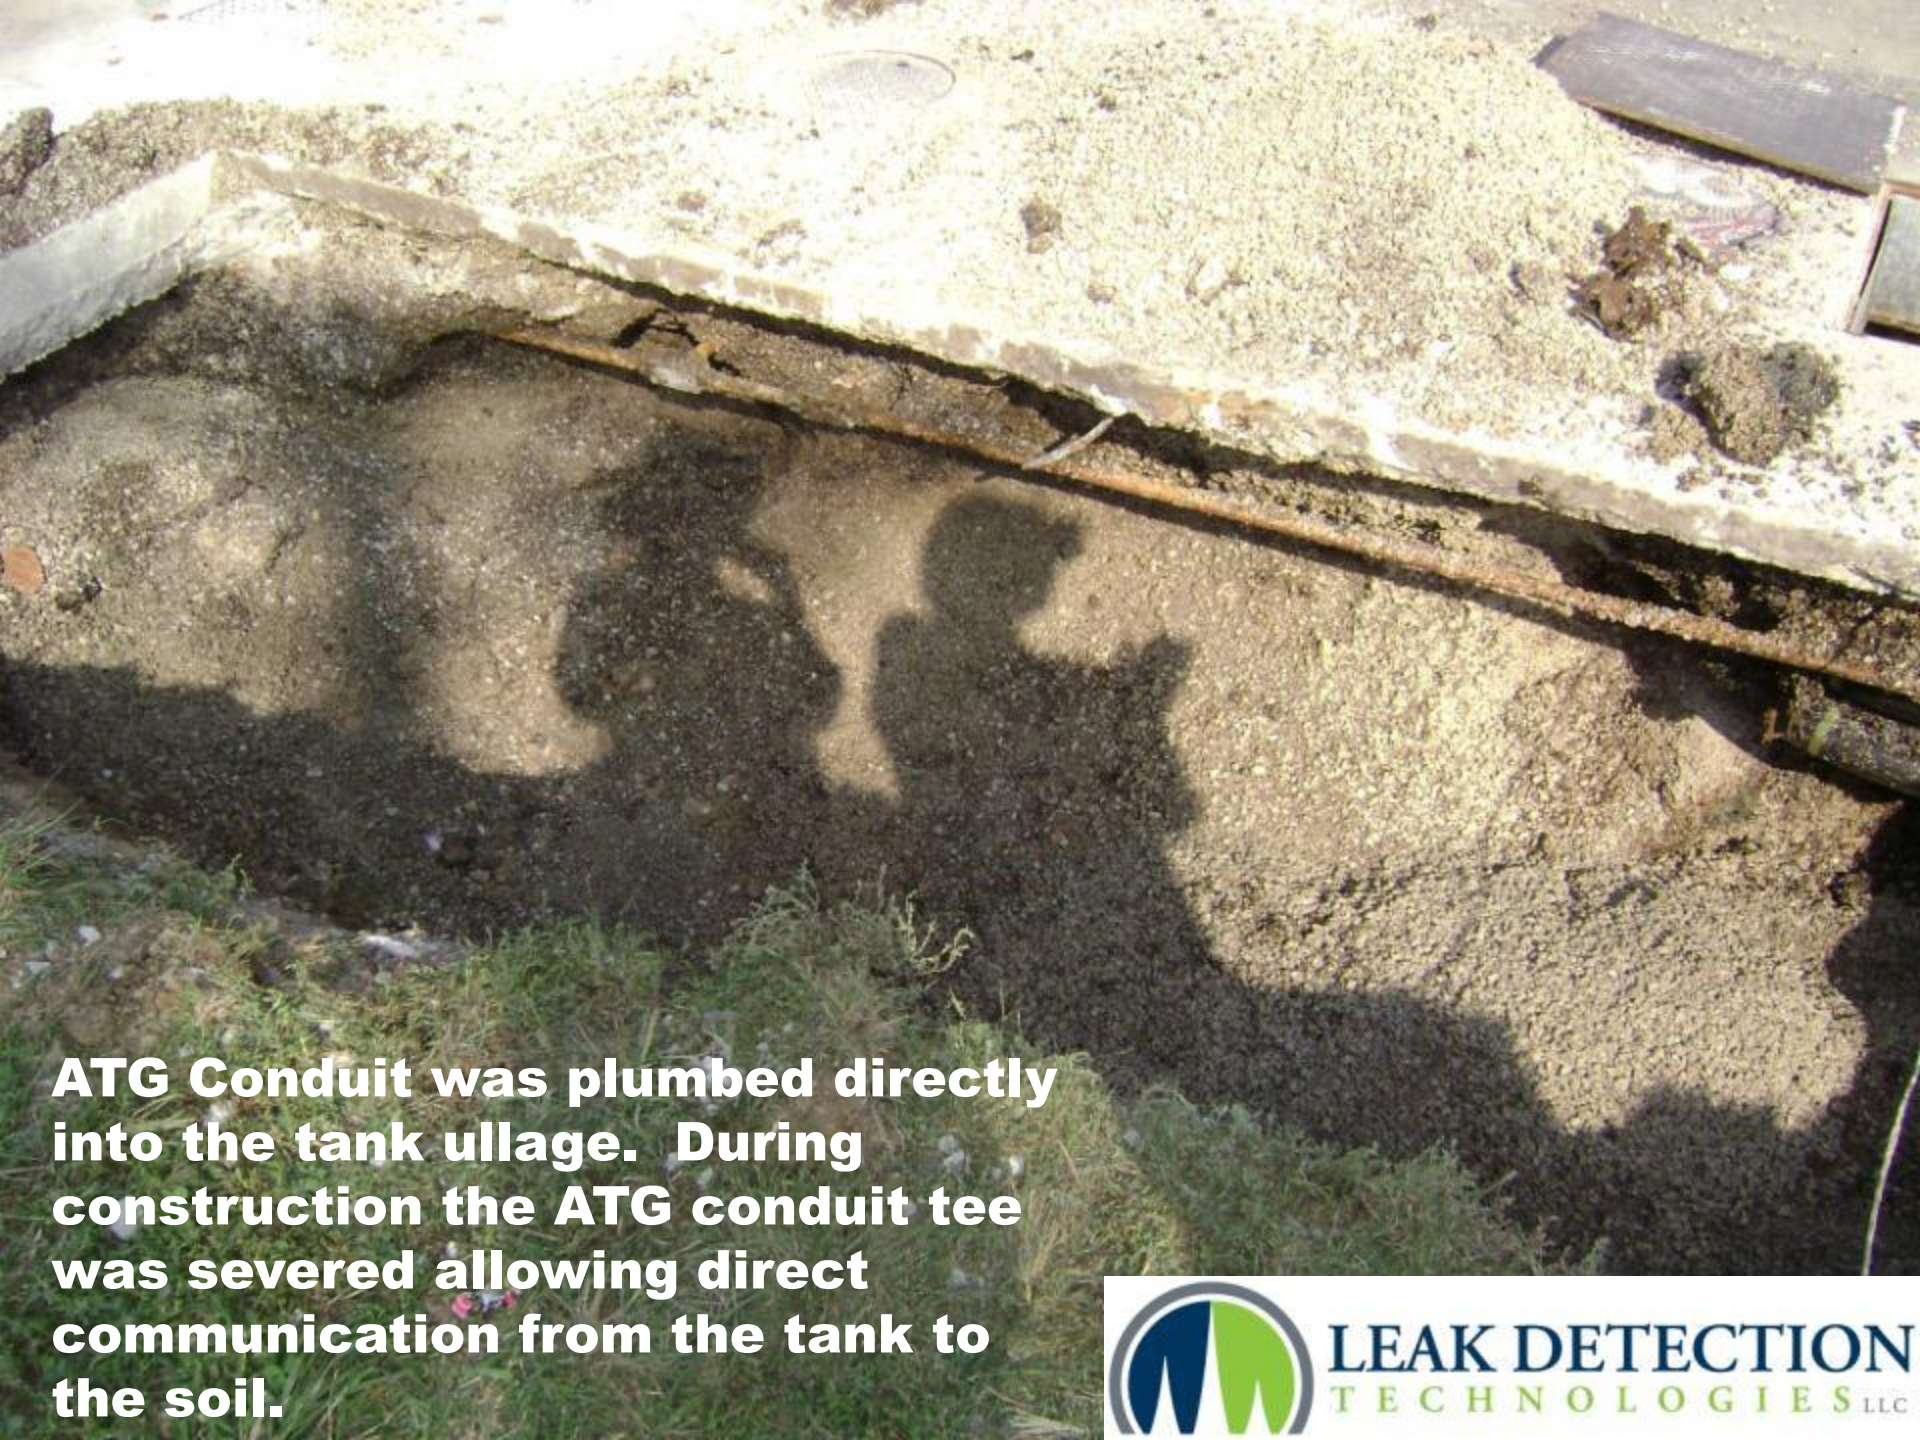
**ATG Conduit was plumbed directly into the tank ullage. During construction the ATG conduit tee was severed allowing direct communication from the tank to the soil.**

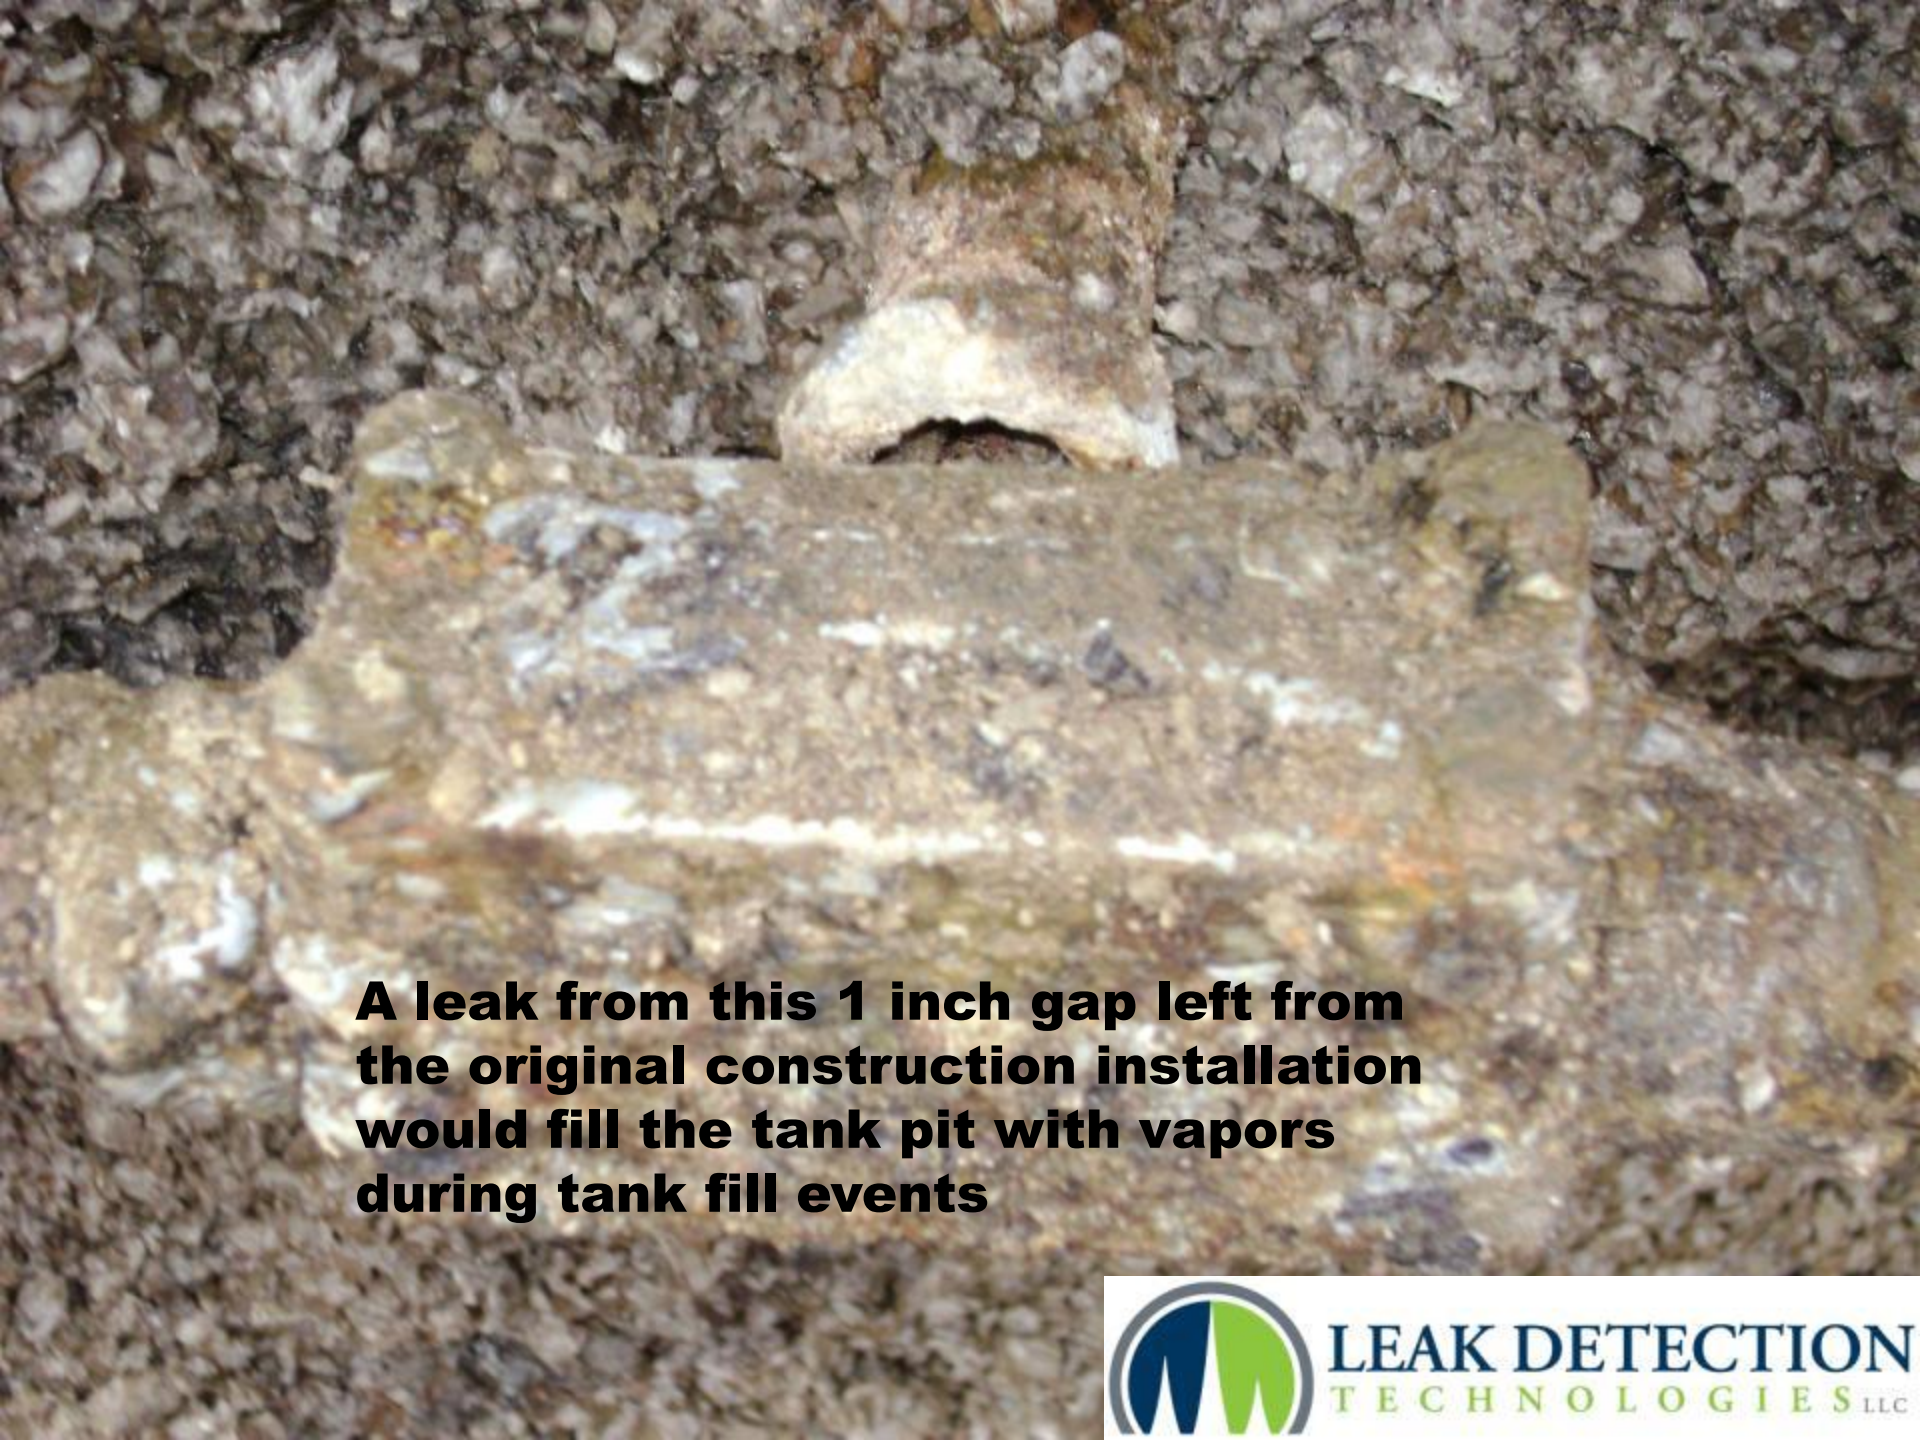
A close-up photograph of a concrete structure, likely a tank pit, showing a significant gap in the construction. The gap is approximately 1 inch wide and is located at the top of a vertical concrete wall. The surrounding concrete is heavily stained with yellow and brown marks, indicating potential leaks or spills. The ground surface is composed of dark, loose gravel.

**A leak from this 1 inch gap left from  
the original construction installation  
would fill the tank pit with vapors  
during tank fill events**

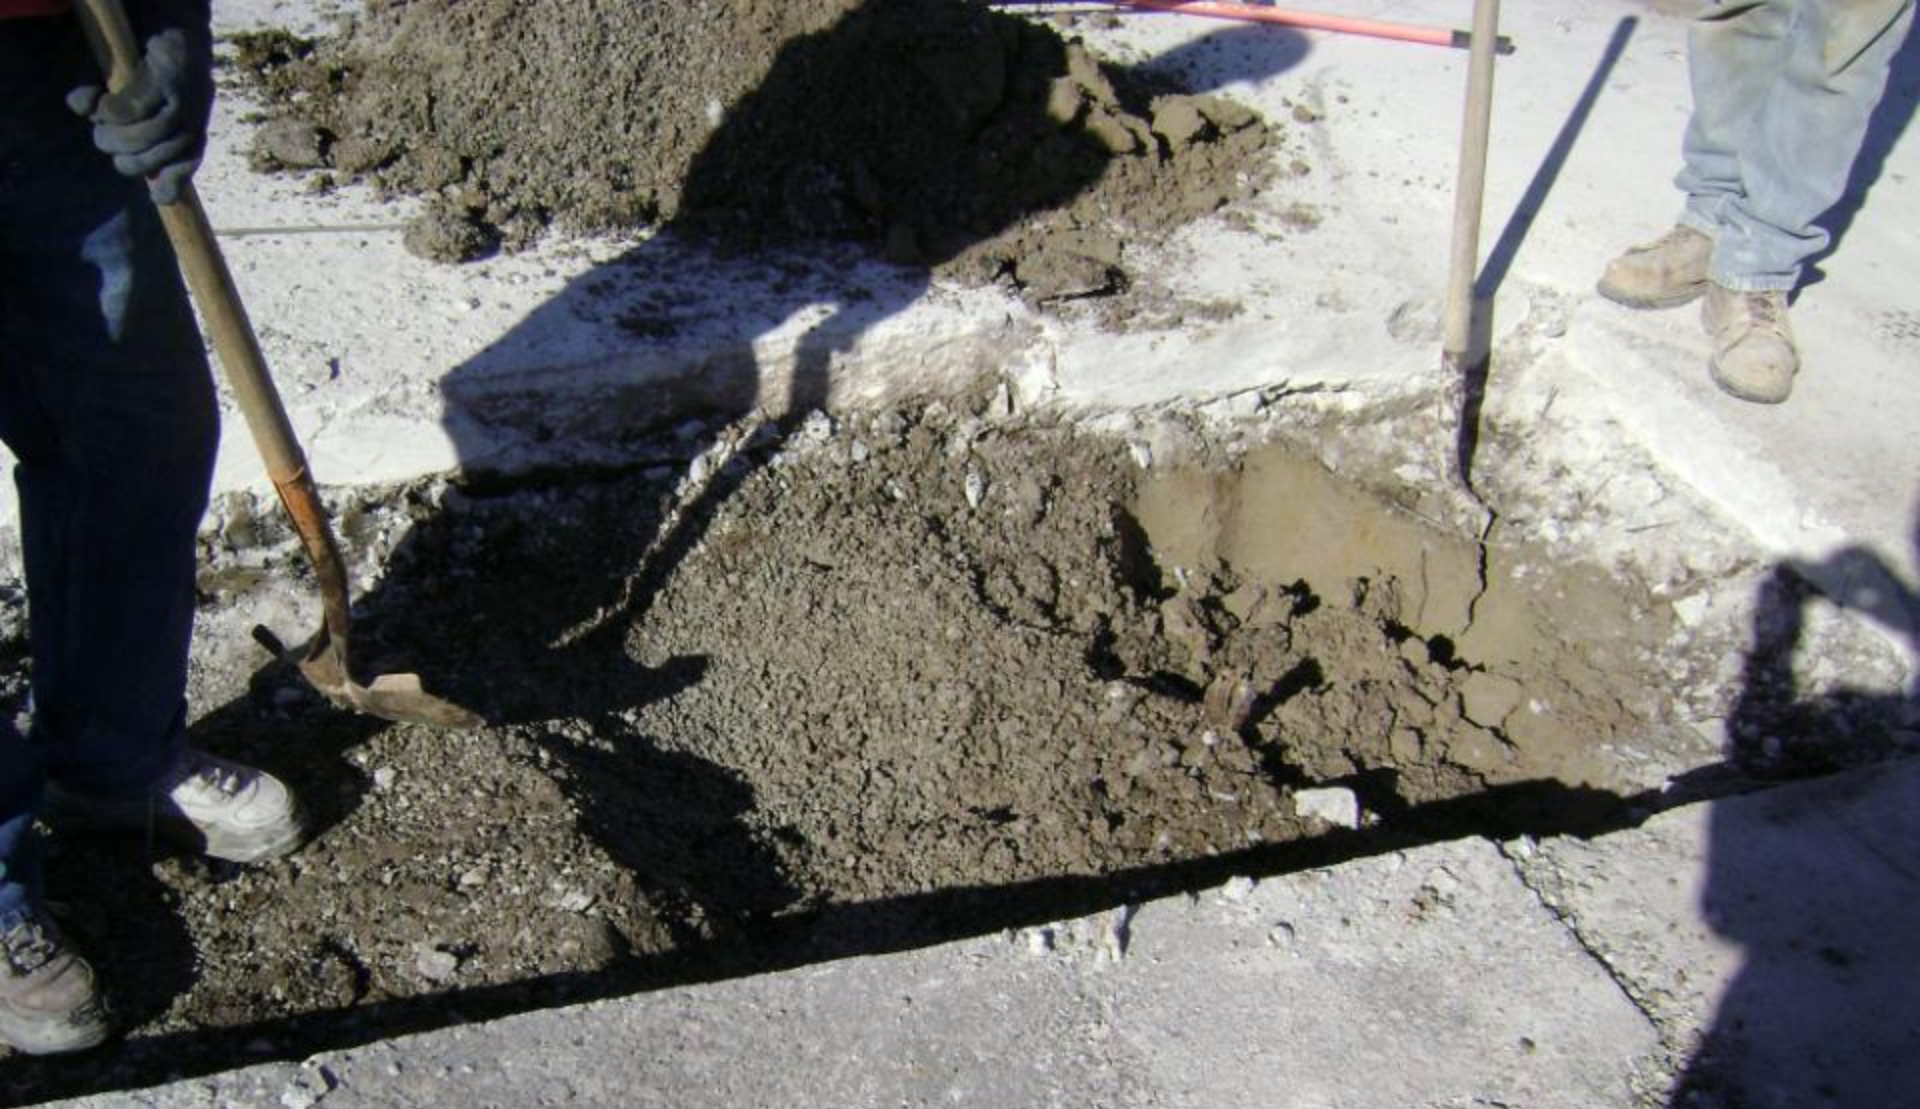
**Leak was detected in pipeline.  
Contractor saw cut as directed  
and found the cause of the leak  
within the first shovel removals.**

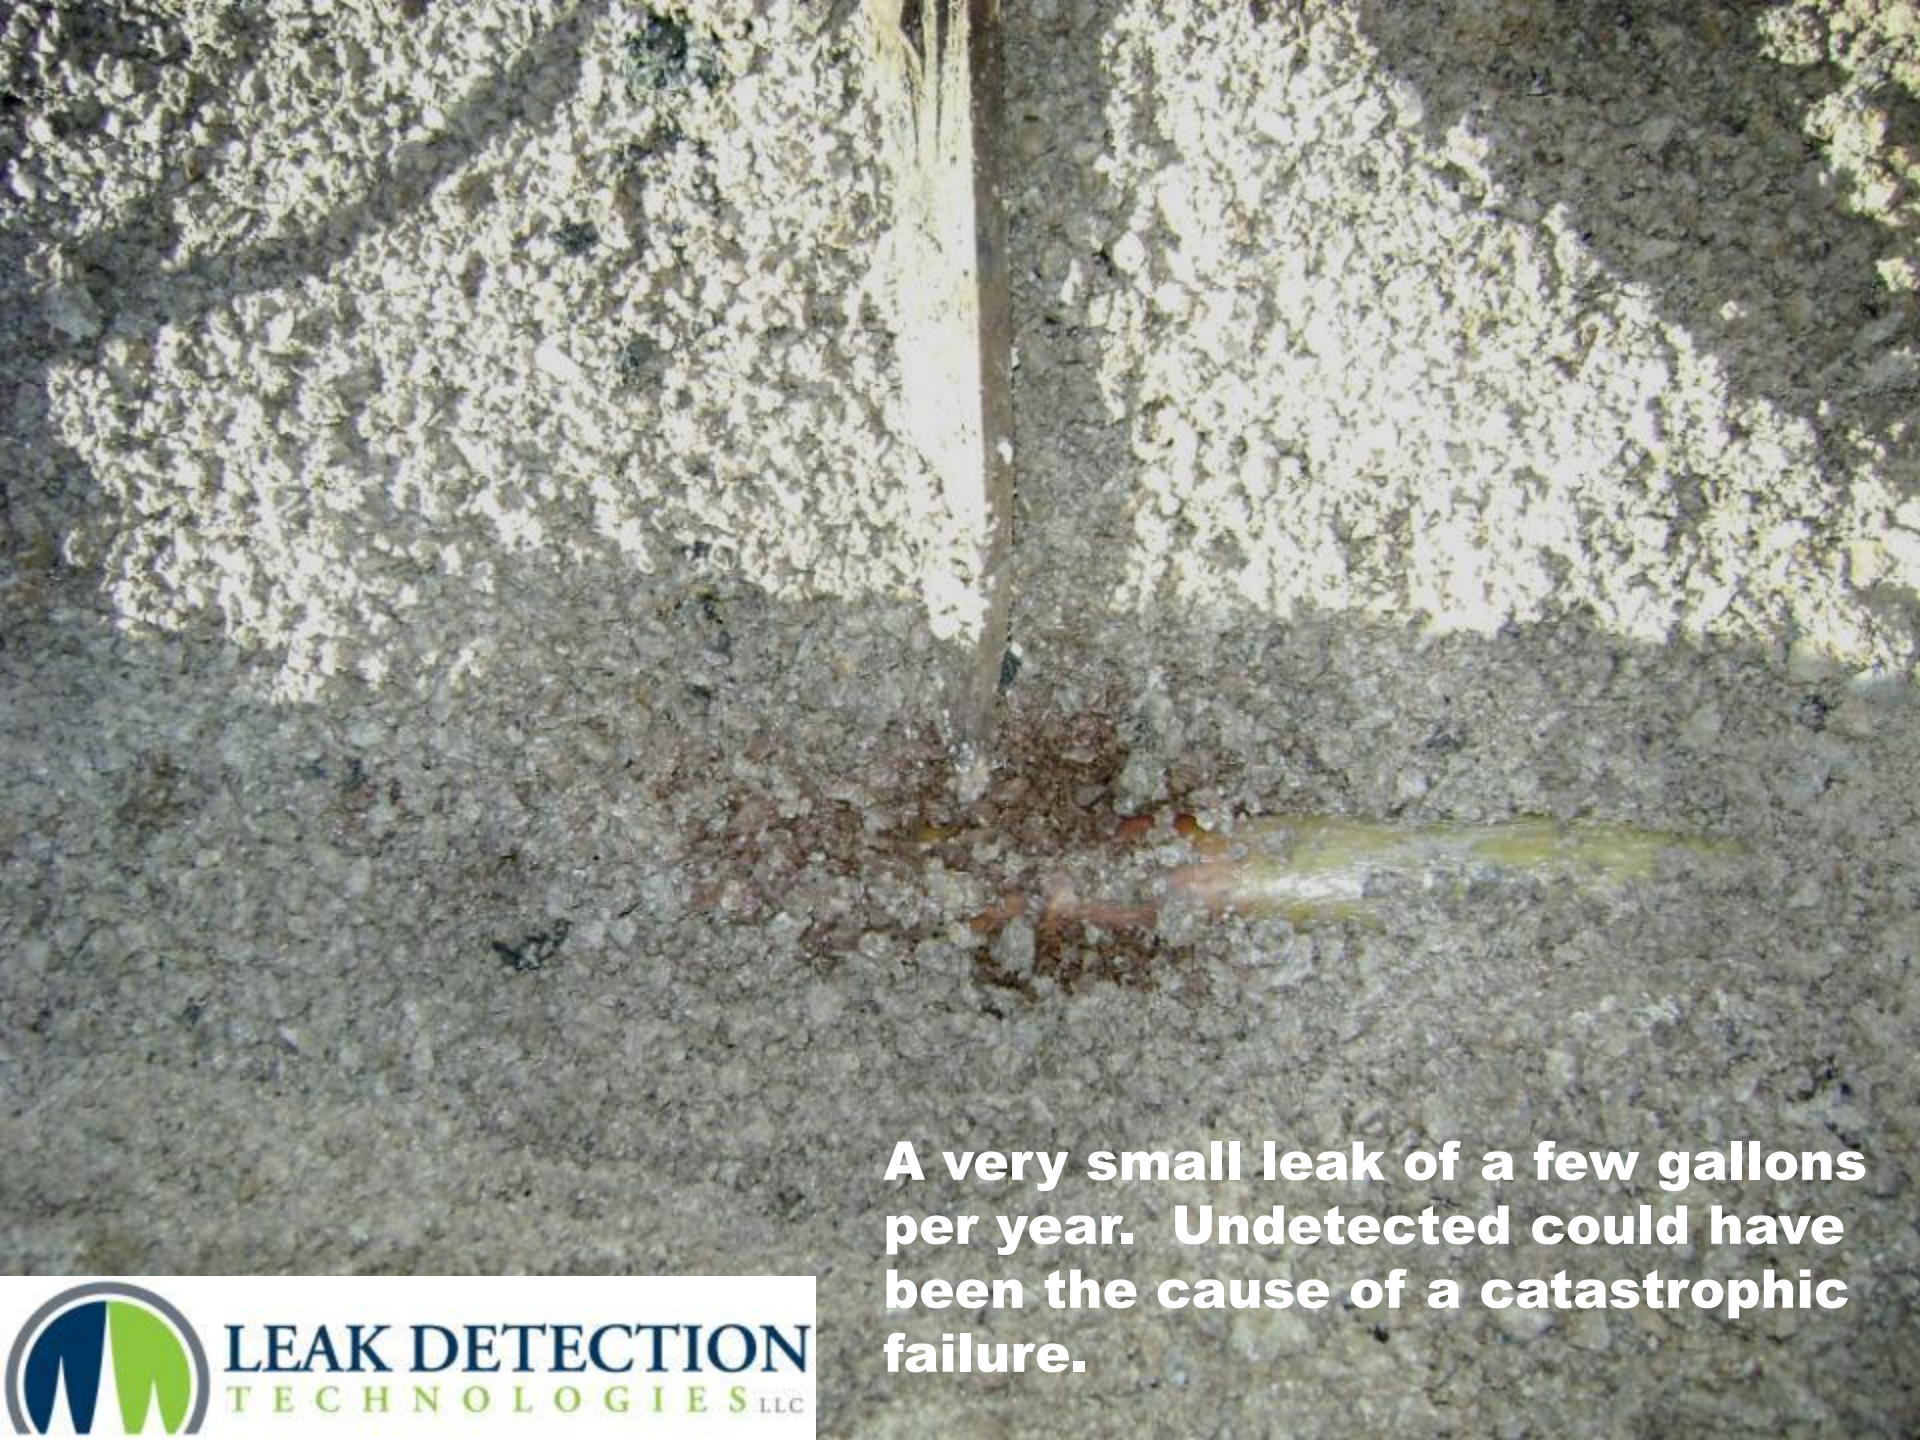
**A very small leak of a few gallons per year. Undetected could have been the cause of a catastrophic failure.**

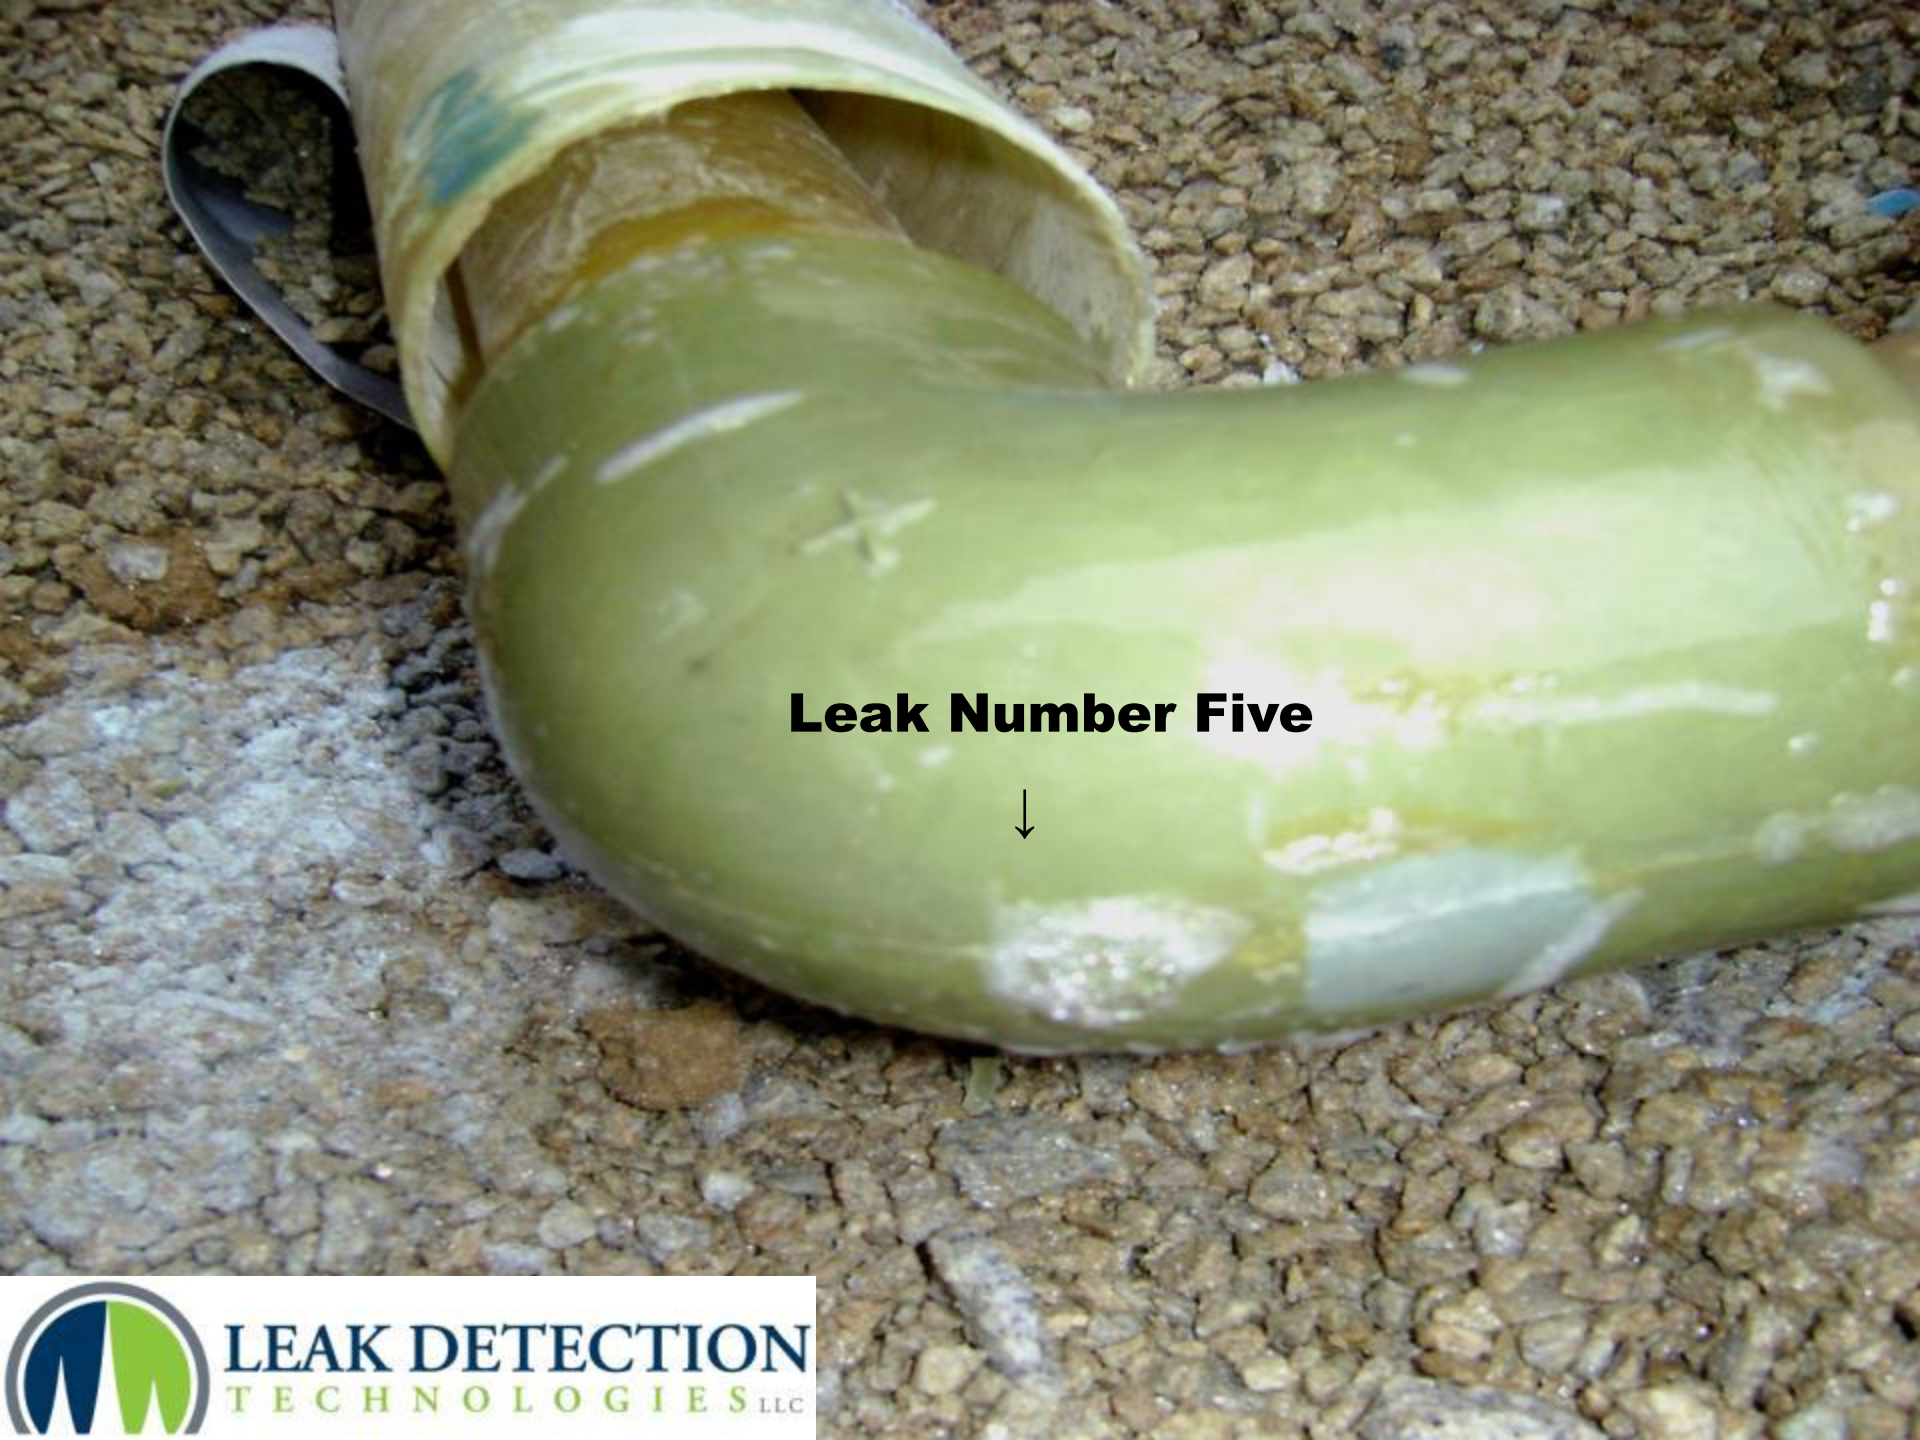
**Leak Number Five**

A large, translucent green pipe is shown lying on a gravel surface. The pipe has a white 'X' mark on its side. A black arrow points down from the text 'Leak Number Five' to a small, white, irregular mark on the pipe's surface, indicating a leak site. The pipe is partially cut open at one end, revealing a brown interior.

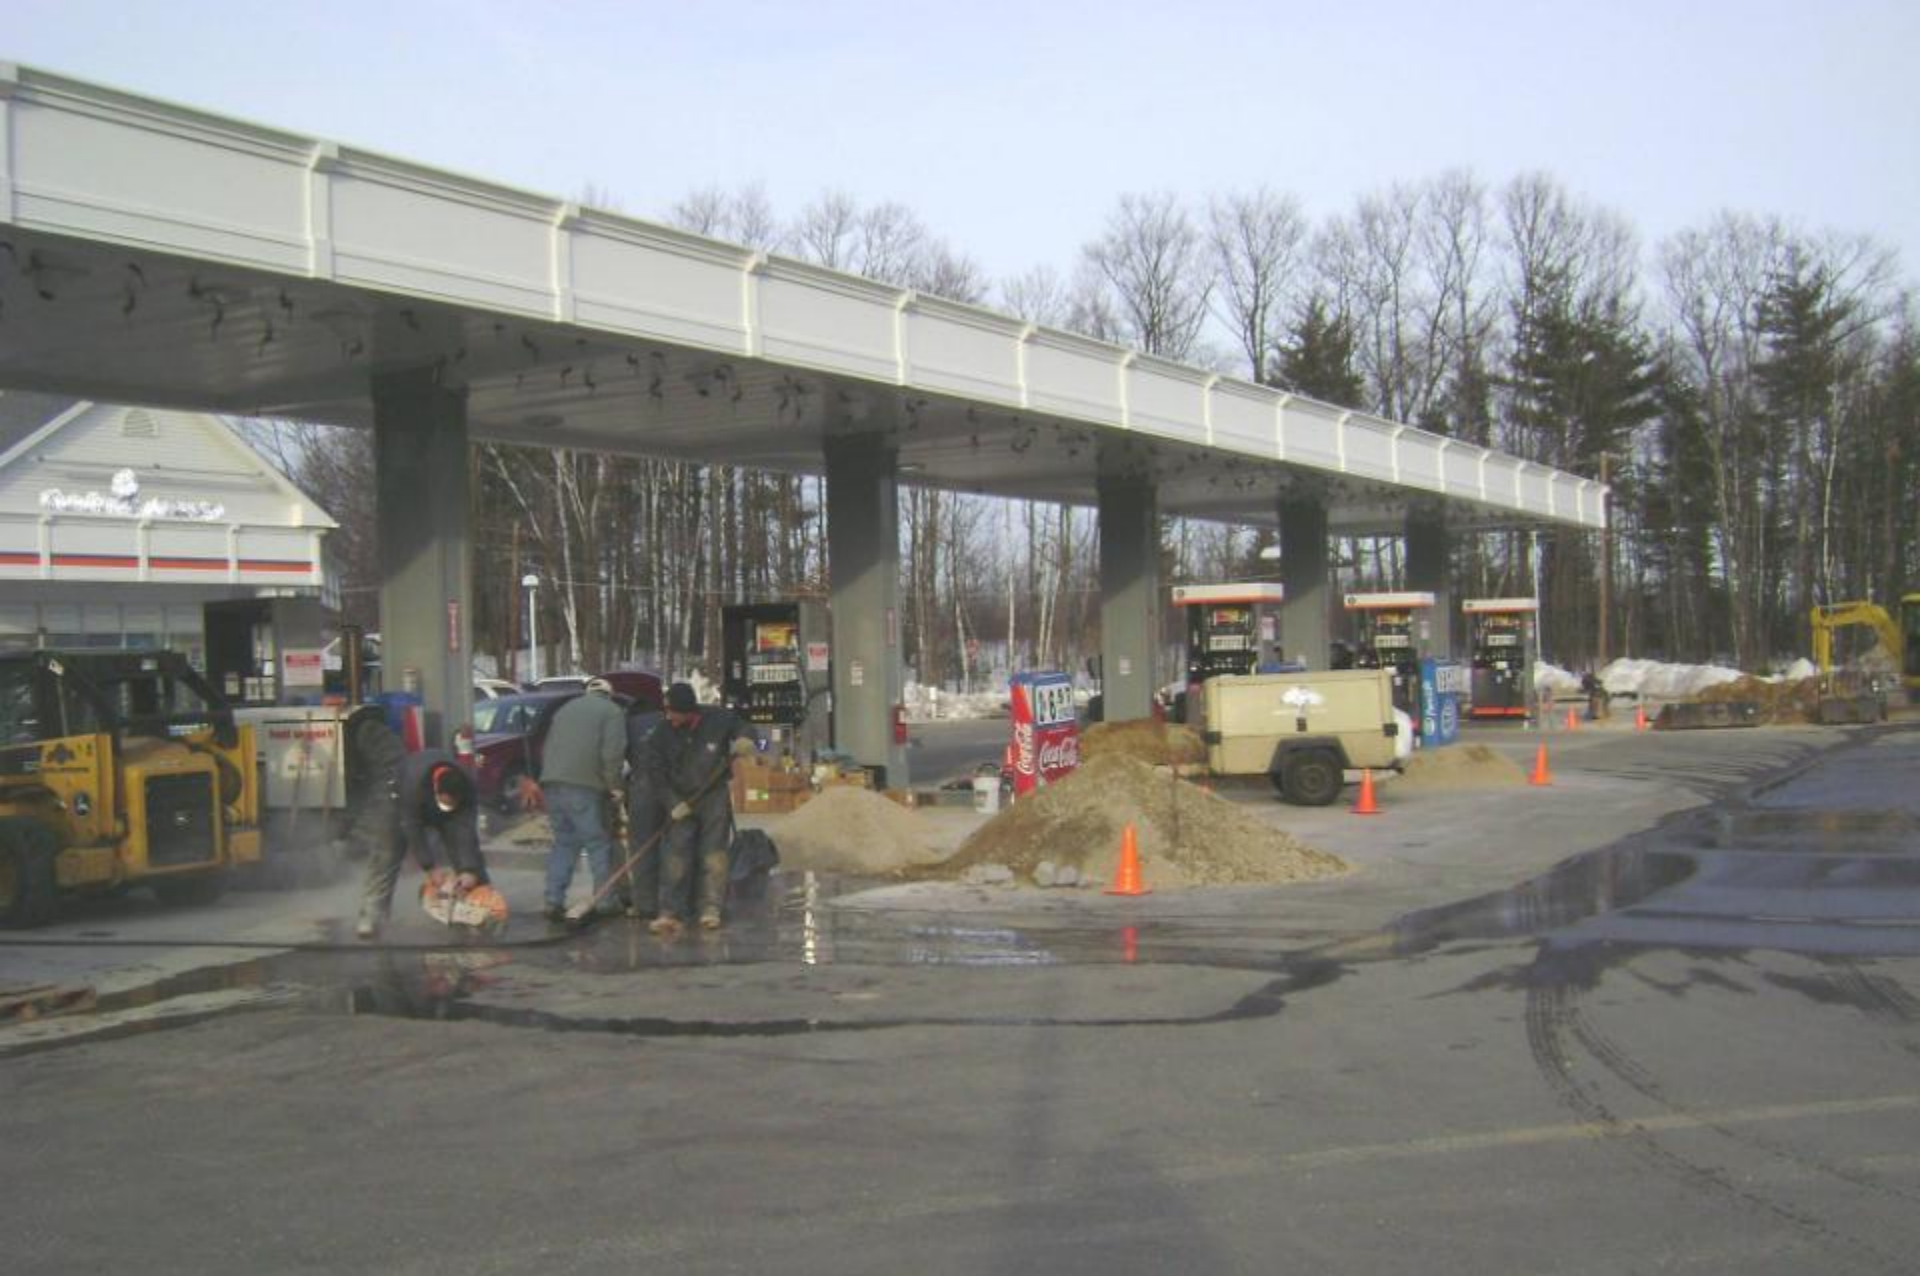
**Minor Interruption to Traffic**
