## FINAL REPORT

Contractor: Caledonia County NRCD

**Project Period:** 06/01/2023 to 03/05/2024

# RESTORING ACCESS TO UPSTREAM HABITAT ON A TRIBUTARY TO STANNARD BROOK

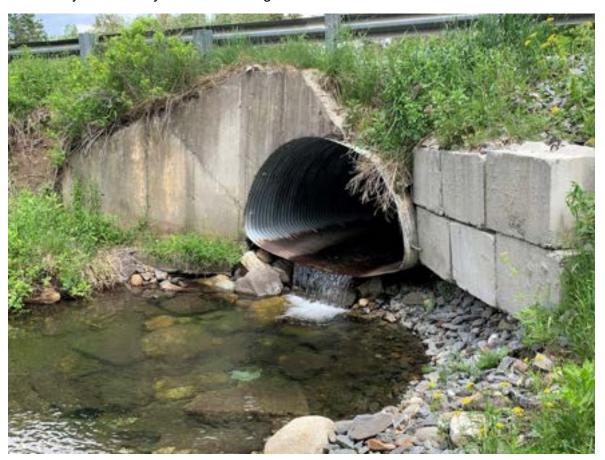
Figure 1 Hutchins Farm Rd culvert before construction

The purpose of this project was to replace a culvert under Hutchins Farm Road in Stannard with a concrete bridge. The previous structure was perched, blocking access to high-quality climate change resilient habitat for eastern brook trout; mis-aligned, creating hydraulic impacts on the upstream side; and too small, resulting in insufficient vertical and floodplain connection for the channel along this stretch of stream. This project took place in Stannard, located in Caledonia County and the Lamoille River Watershed. Construction took place in September 2023, and was complete by Friday, October 6th, 2023.

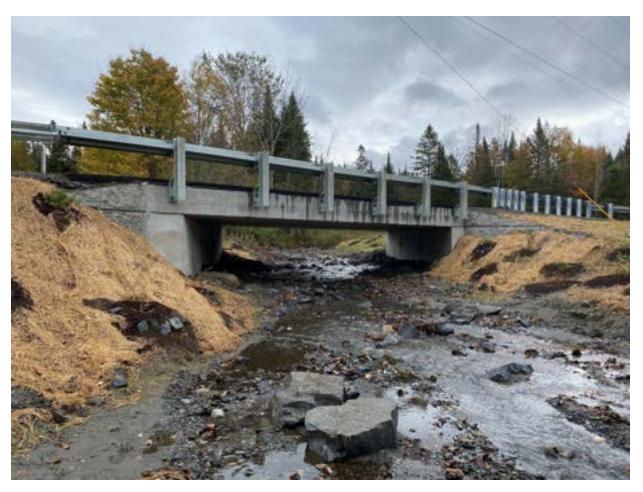
Figure 2 Hutchins Farm Rd bridge after construction
